**REPORT OF THE AD HOC ADVISORY COMMITTEE
ADVISORS ON THE JULY 11, 2021, FLOODING AT THE
HYPERION WATER RECLAMATION PLANT AND
RECOMMENDATIONS FOR FUTURE IMPROVEMENTS**

February 11, 2022

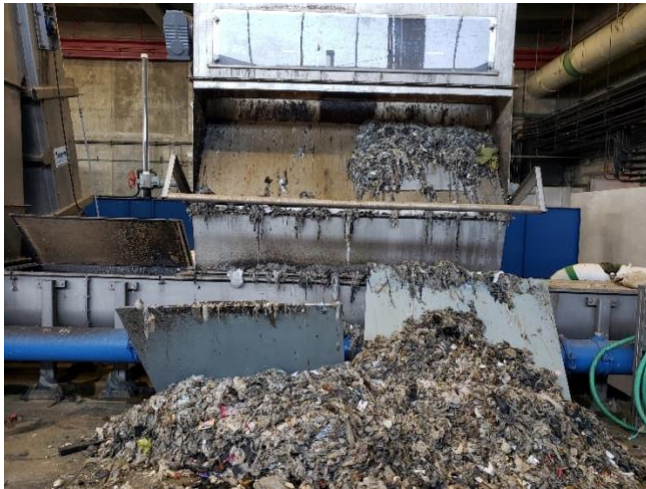
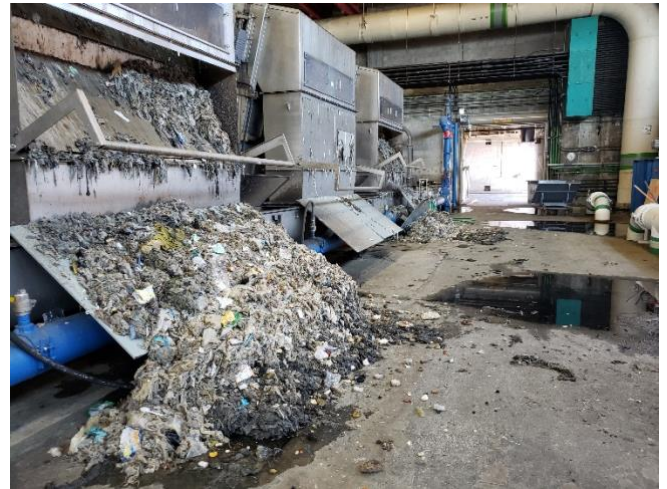
Figures 7 and 8: Back sides of the bar screens, opened to remove screenings (instead of using the sluice).

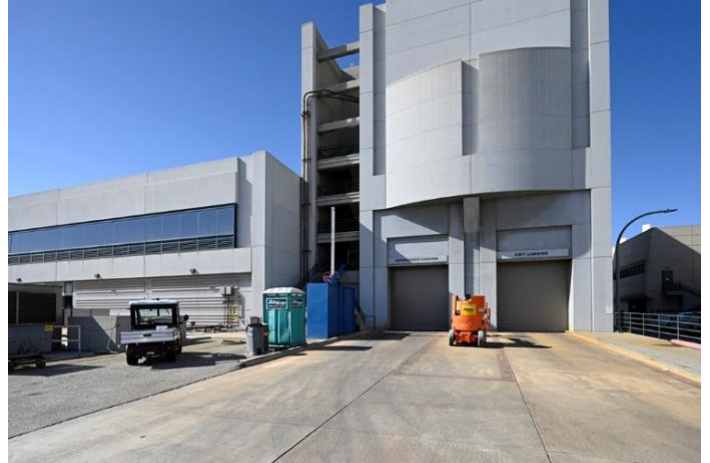
Figure 21: Back of the Headworks building showing large doors for screenings removal trailers. Flood waters exited through these doors.

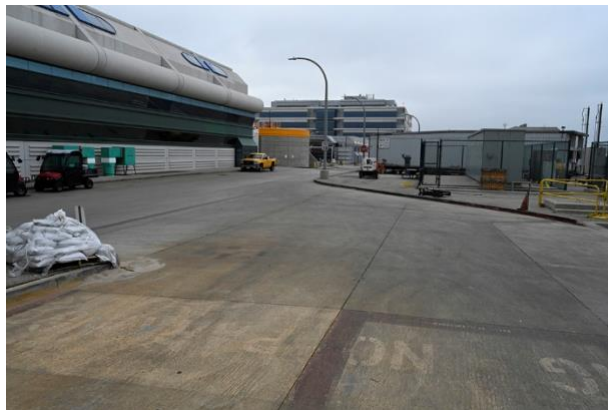
Figure 22: Road and parking area where flood waters flowed to the secondary treatment part of the plant.

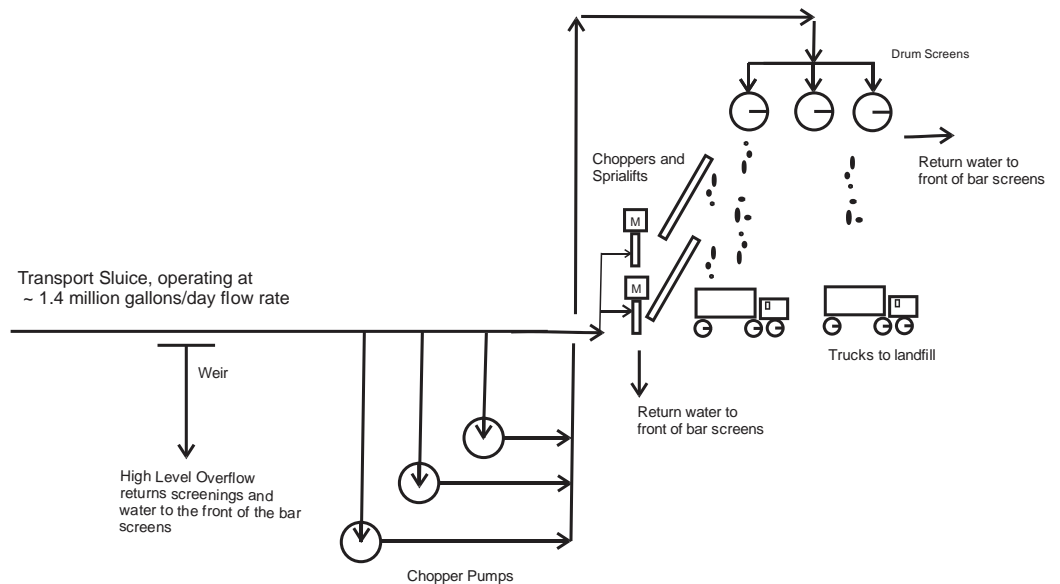
Figure 24: Schematic of screenings removal system. The sluice transports screenings to the pipes downward to the chopper pumps or to the choppers and spiral lifts. There is an overflow weir that allows water at high levels to overflow back to the front of the screen.

type of chopper. From there, the screenings are fed to a spiral lift, which is a type of screw conveyor and allows water to drain while transporting the screenings upward to be dumped into the same trucks. There are at least two hypothetical cases that could have caused the screens to blind. The Bureau of Sanitation's 30-day report [\(1\)](#) suggests that a large mass of debris entered the plant and blinded the screens. This report was created early in the investigation and was based on the best available information at the time. This potential cause is possible, but the subsequent Brown and Caldwell reports did not find evidence in the conveyance system of a previous or current accumulation of debris. The report did find an accumulation of grit near and around the sluice gates. Although grit normally does not blind screens, the accumulation may have contributed to the problem.

Prior to the event, the Bureau of Sanitation 30-day report also notes the failure of a chopper pump on July 11, and a spiral lift was out of service before July 11. Based on the investigation by CDM Smith, it appears possible that both systems to remove screenings could not keep up with the rate of removal of screenings and forced an overflow and recycling of screenings at the point shown in Figure 24. The Committee Advisors conclude that this is the most likely explanation for failure of the screens. Recycling of screenings would eventually overcome the bar screens and result in blinding and the increase of the wastewater level upstream of the screens. Under normal conditions, these screenings would have been transported to the trucks via the choppers. This recycling of screenings could have led to ultimate flooding of the Headworks.

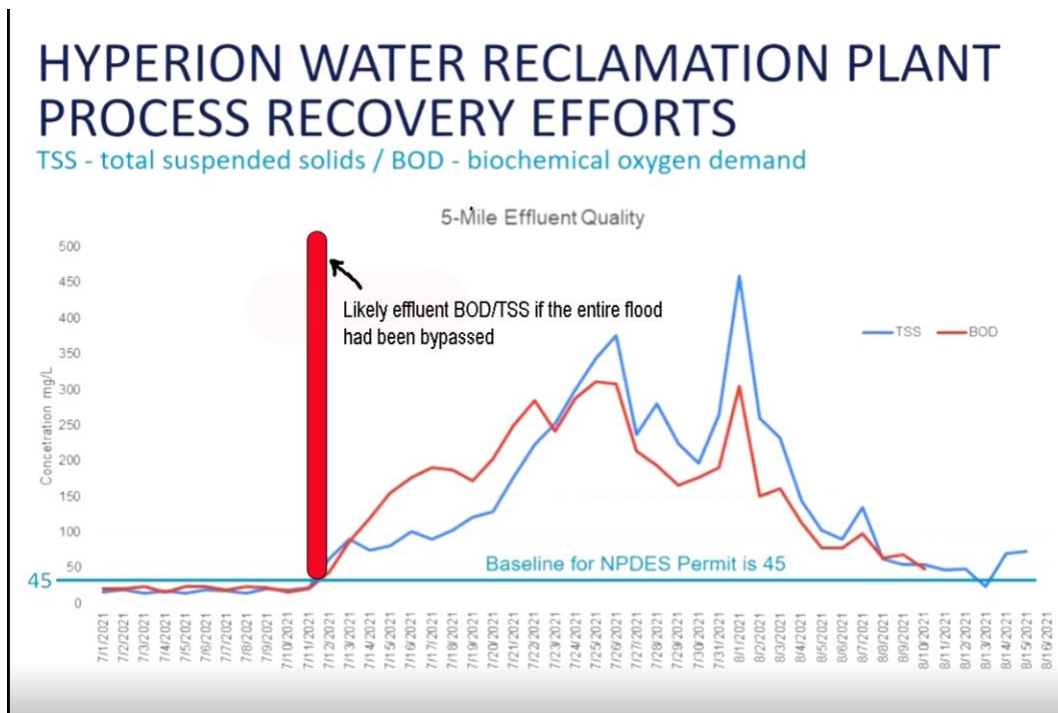
In this hypothetical case, the damage to the plant might have been avoided. Figure 25 (below) is a graph that shows the discharge of TSS and BOD after July 11 (graph from BOS’s Zoom meeting with the City of El Segundo, 8/17/2021). The loss of secondary treatment caused the effluent TSS/BOD to increase at times to basically the influent concentrations. The vertical red bar is a model of the effluent BOD and TSS that might have occurred if the flood waters had been diverted. The mass discharges of BOD and TSS are calculated from the graph using a flow of 280 MGD.

Figure 25: TSS and BOD discharges after the July 11 flood and a hypothetical discharge if all the flood water had somehow been diverted to outfalls, preventing damage to the plant.

The modeling predicts that a hypothetical diversion which could have avoided Hyperion damage would also have reduced BOD and TSS mass discharges by more than 99%. Because this hypothetical is based on a model, actual results can differ. Additional analysis is needed prior to invoking this approach to better ensure that the model results would reflect a real time flooding incident.
