**REGULAR MEETING OF THE
Board of Directors of the
El Segundo Senior Citizens Housing Corporation
AGENDA
In-Person Meeting**

MEETING DATE: Wednesday, August 28, 2024

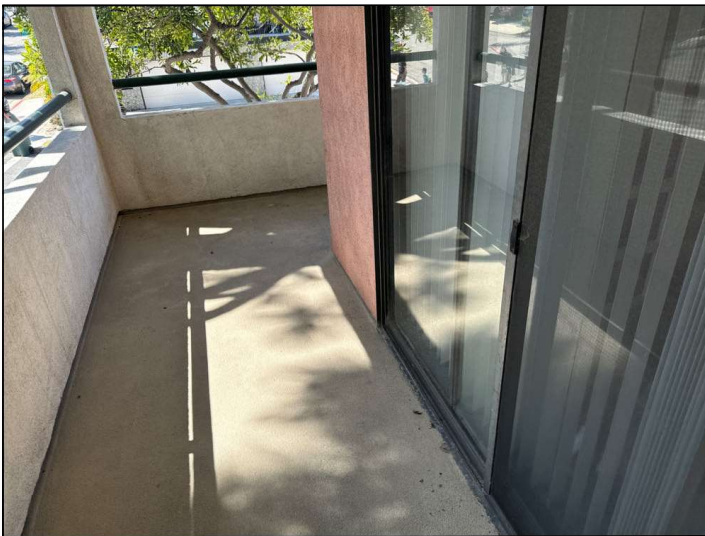
Balcony's underside is covered with wood or stucco and inaccessible for a full inspection. Further evaluation may be necessary. You may consider installing removable ventilation/inspection panels on the underside of the balcony to allow for ventilation and future required (every six years) inspections.

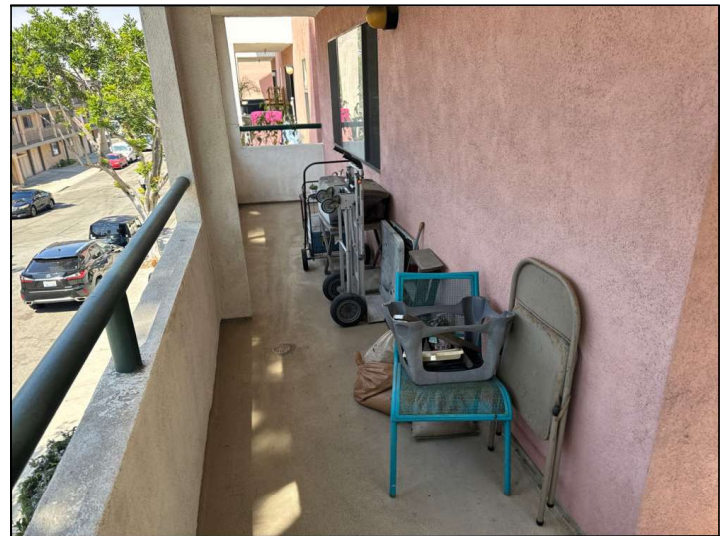
No visible structural problems were observed at the time of inspection.

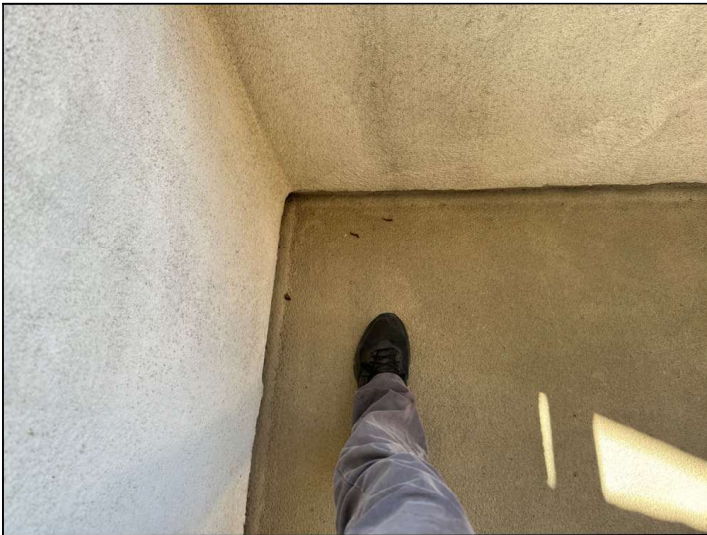
The Magnesite floor coating is damaged, cracked, bubbling or deteriorated. Repairs or resurfacing should be considered.

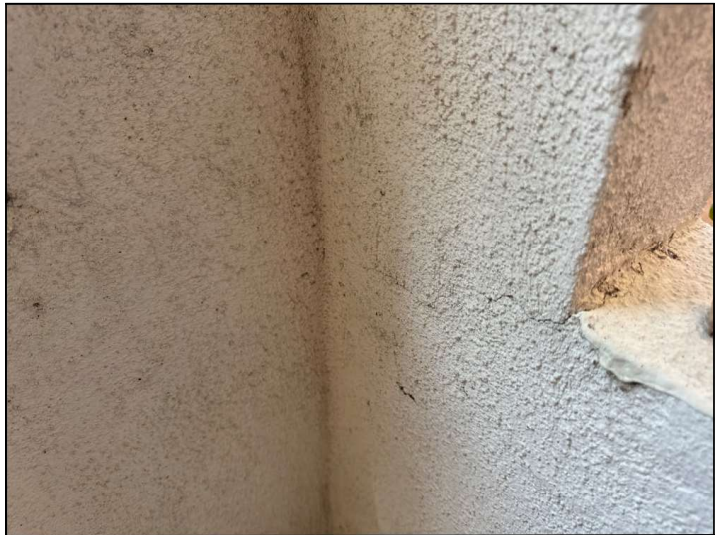
Flashings are not properly sealed at the stucco railing junction and may allow moisture penetration and damage.

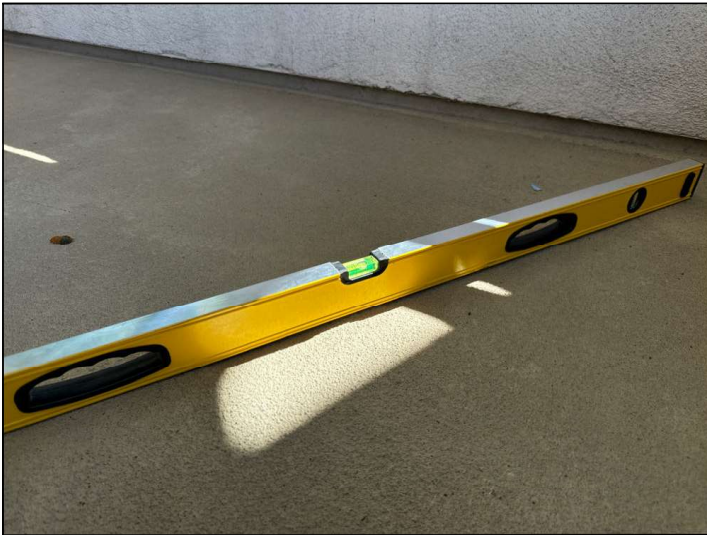
The Balcony floor is improperly sloped towards the structure instead of away. This will cause moisture to pool at the wall-to-floor junction or cause moisture to penetrate into the dwelling.

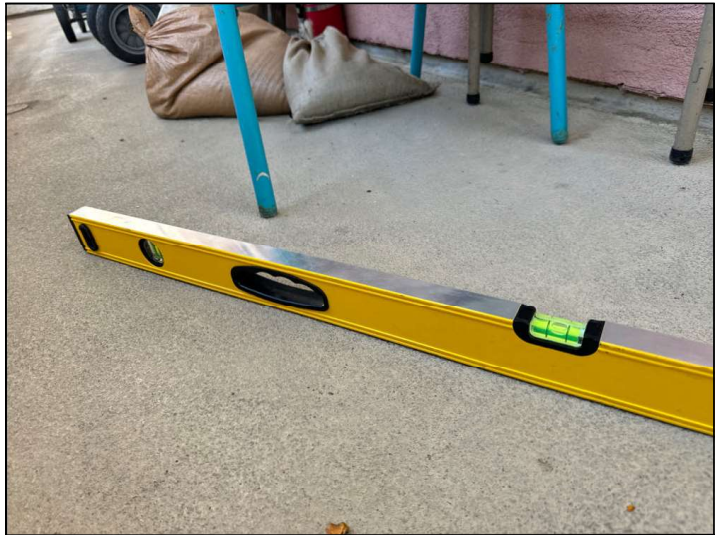
The Balcony floor is improperly sloped towards the structure instead of away. This will cause moisture to pool at the wall-to-floor junction or cause moisture to penetrate into the dwelling.

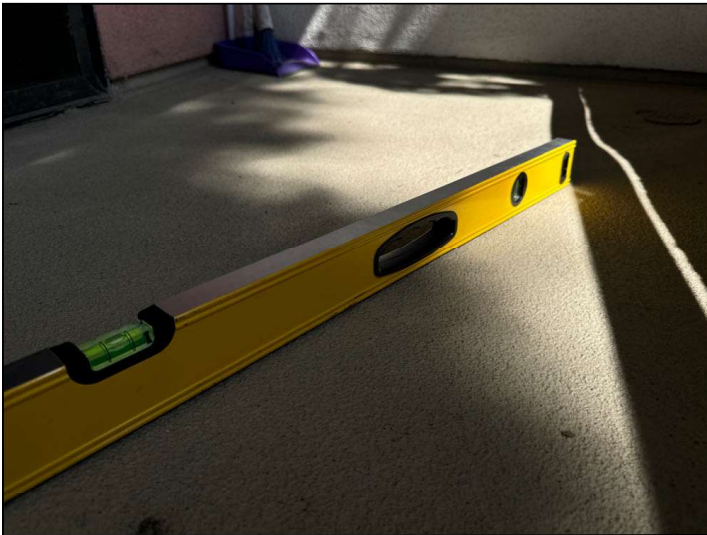
The Balcony floor is improperly sloped towards the structure instead of away. This will cause moisture to pool at the wall-to-floor junction or cause moisture to penetrate into the dwelling.

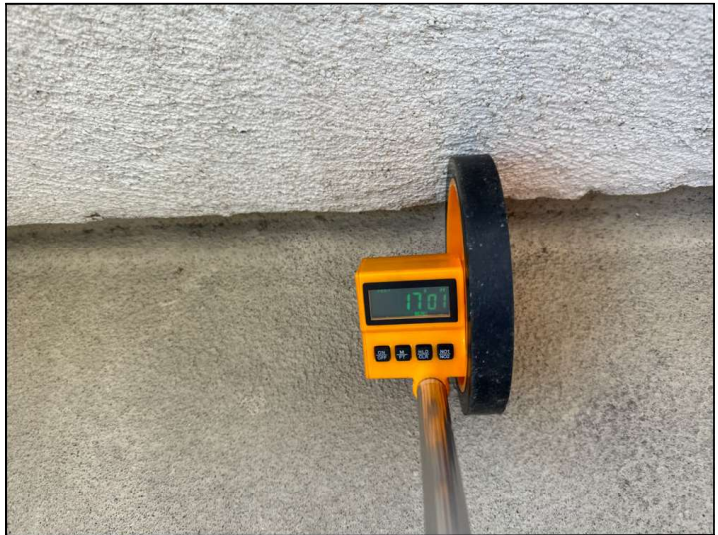
Measurement of balcony in one direction.

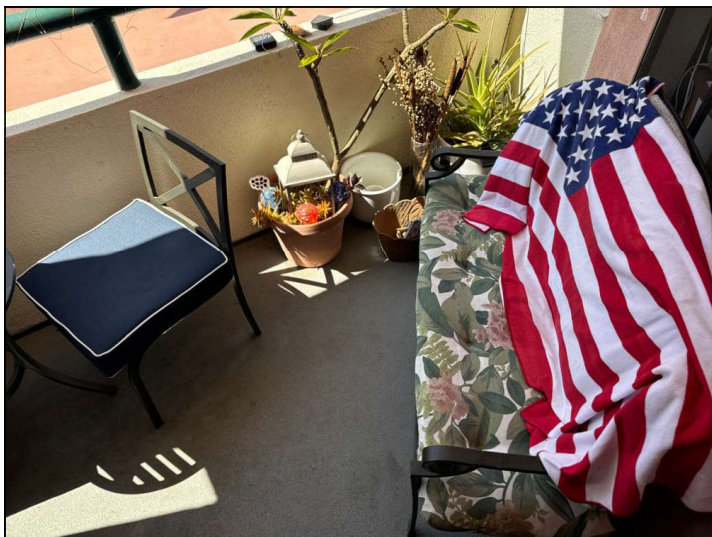
Unable to fully view the balcony due to occupants' belongings. The inspector did not move the occupants' belongings during the inspection. Further evaluation is recommended.

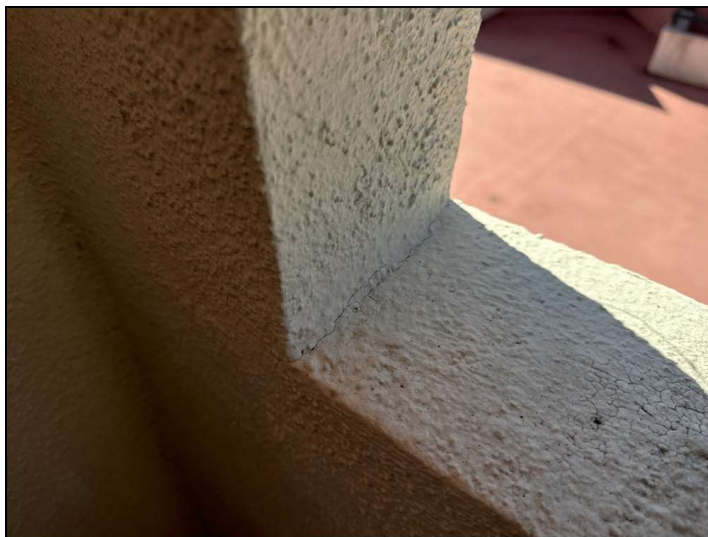
Flashings are not properly sealed at the stucco railing junction and may allow moisture penetration and damage.

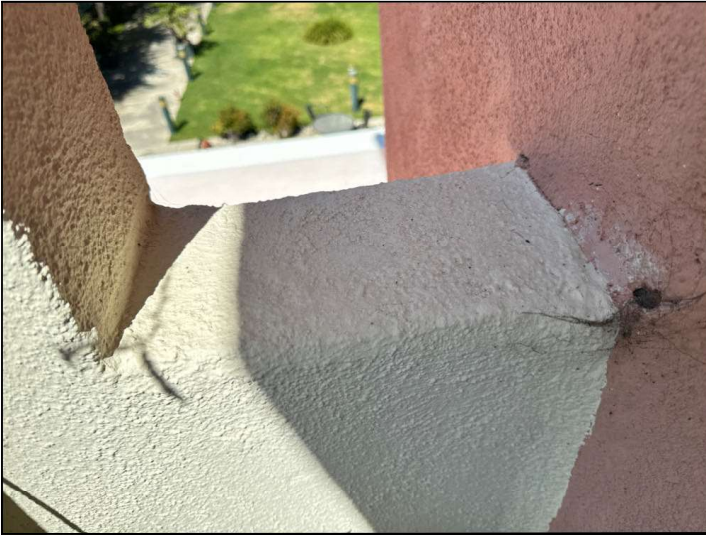
Stucco railing is damaged, cracked or deteriorated and may allow moisture penetration and damage.

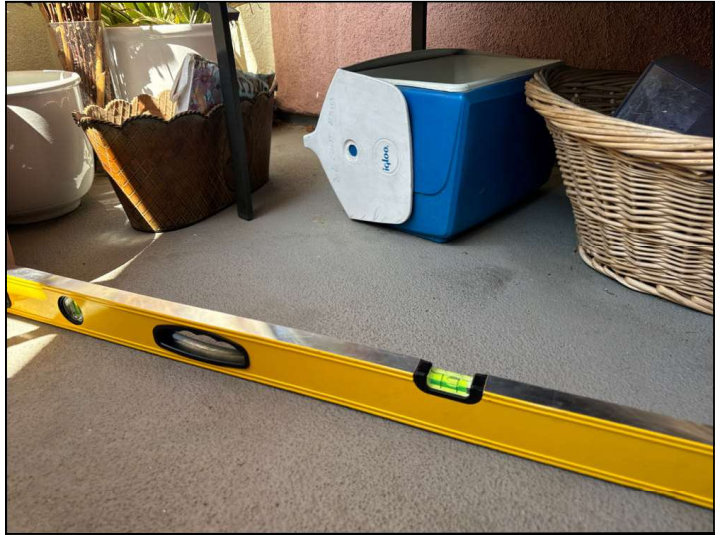
Slope for drainage appears adequate.

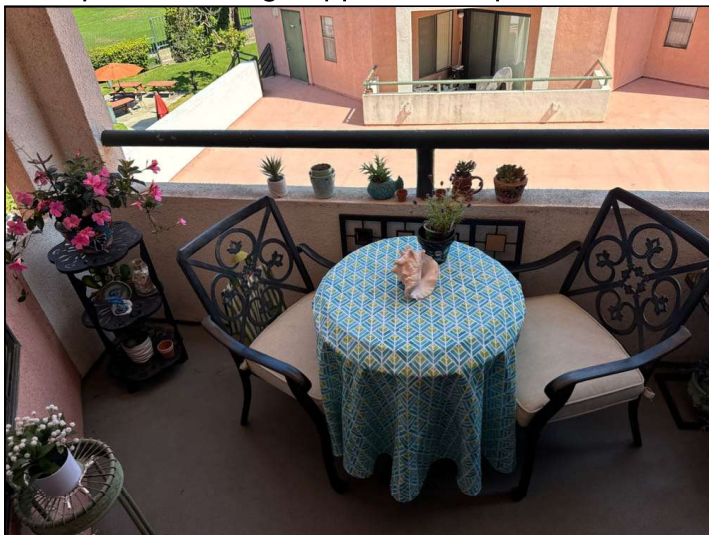
Unable to fully view the balcony due to occupants' belongings. The inspector did not move the occupants' belongings during the inspection. Further evaluation is recommended.

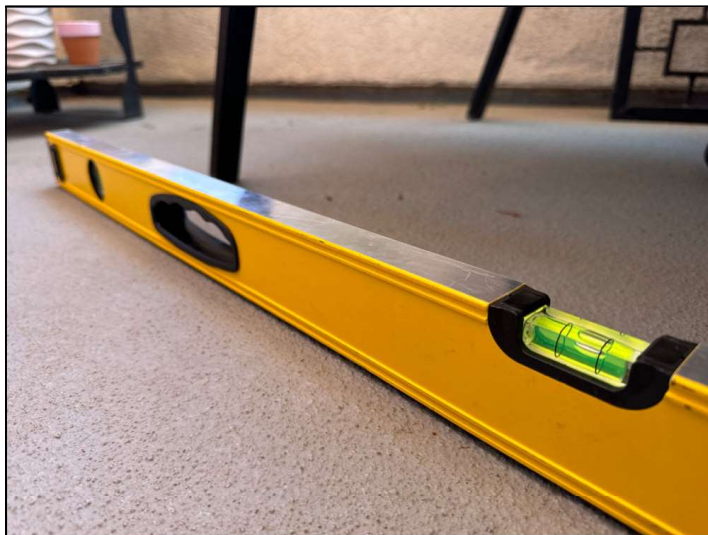
Slope for drainage appears adequate.

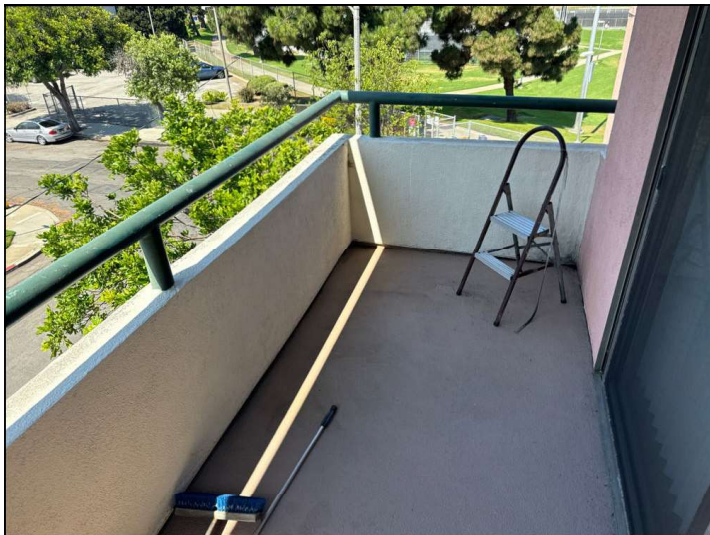
Balcony's underside is covered with wood or stucco and inaccessible for a full inspection. Further evaluation may be necessary. You may consider installing removable ventilation/inspection panels on the underside of the balcony to allow for ventilation and future required (every six years) inspections.

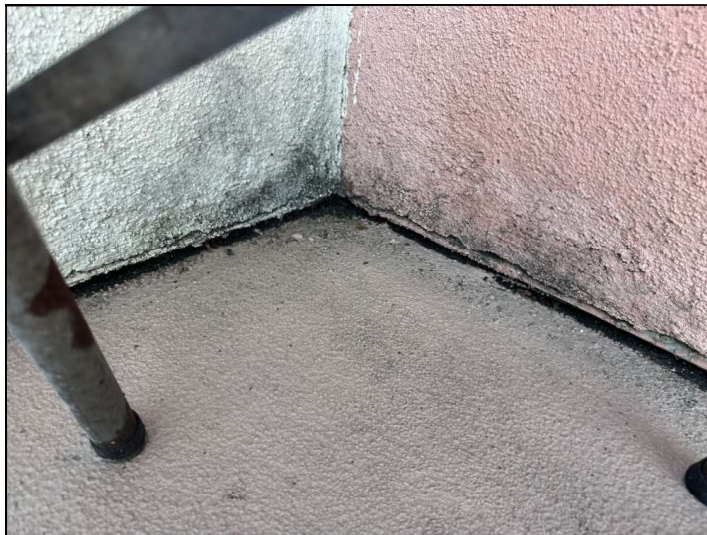
Flashings are not properly sealed at the floor-to-wall junction and may allow moisture penetration and damage.

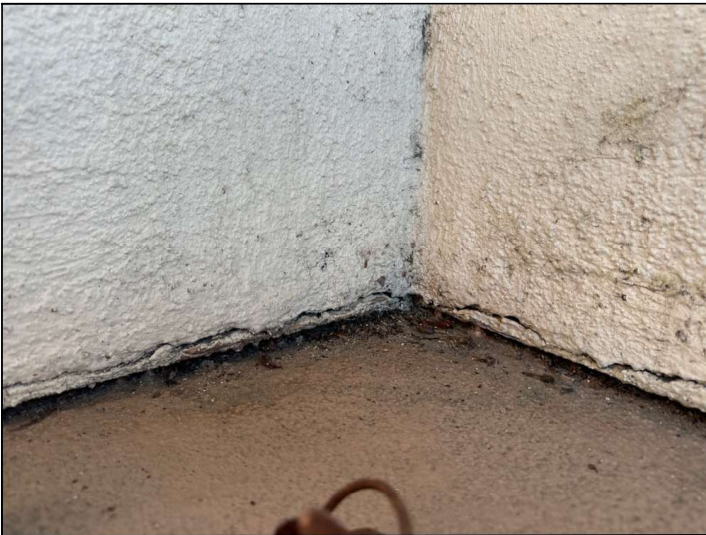
Flashings are not properly sealed at the floor-to-wall junction and may allow moisture penetration and damage.

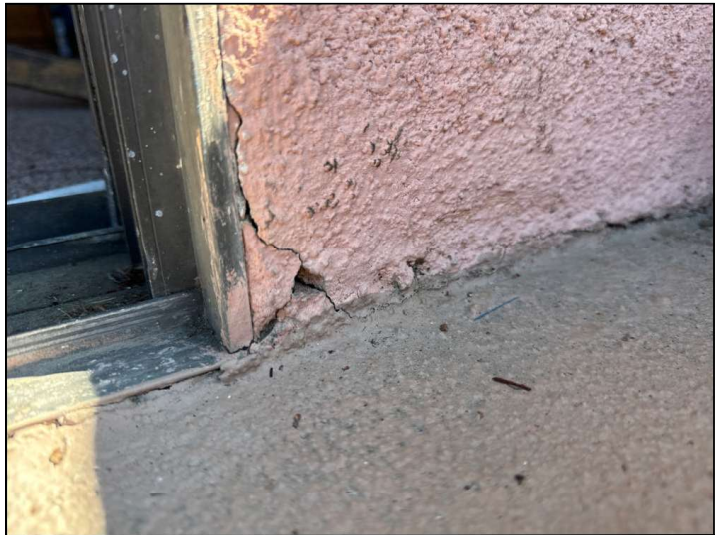
Flashings are not properly sealed at the floor-to-wall junction and may allow moisture penetration and damage.

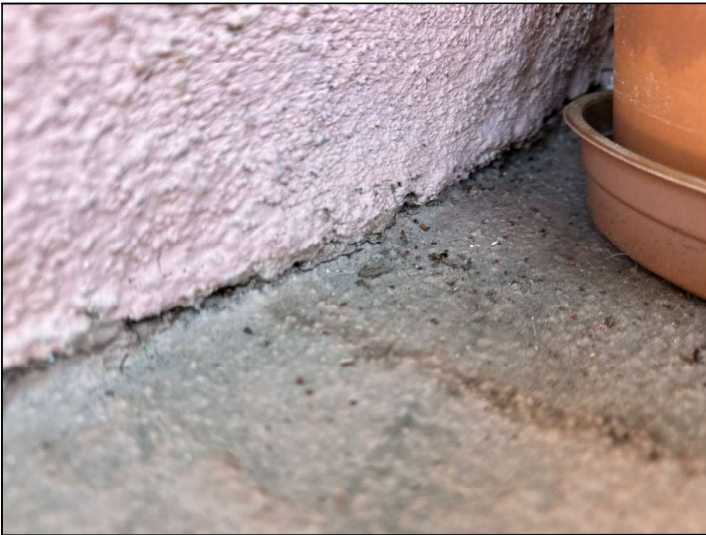
Flashings are not properly sealed at the floor-to-wall junction and may allow moisture penetration and damage.

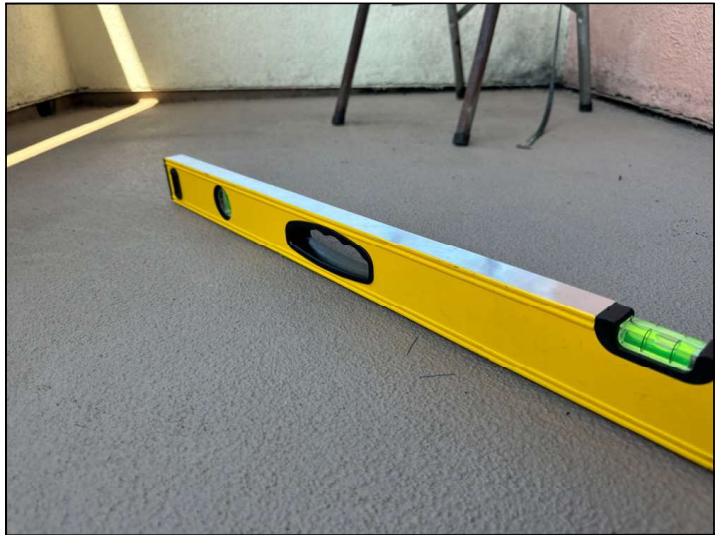
Slope for drainage appears adequate.

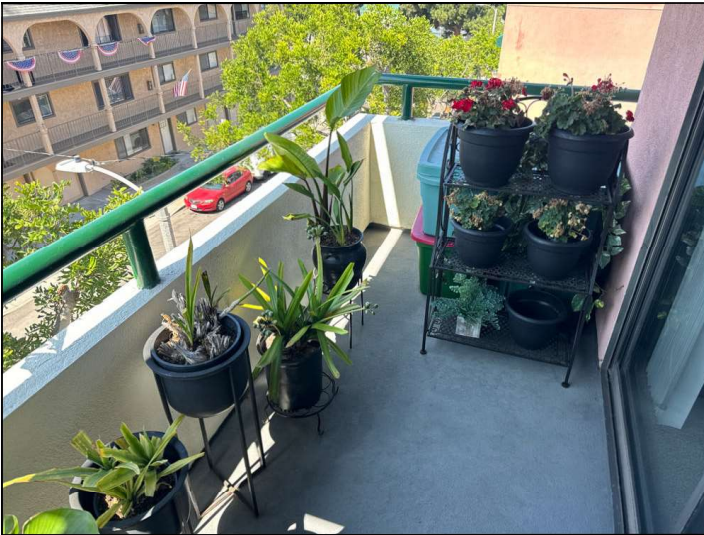
Balcony's underside is covered with wood or stucco and inaccessible for a full inspection. Further evaluation may be necessary. You may consider installing removable ventilation/inspection panels on the underside of the balcony to allow for ventilation and future required (every six years) inspections.

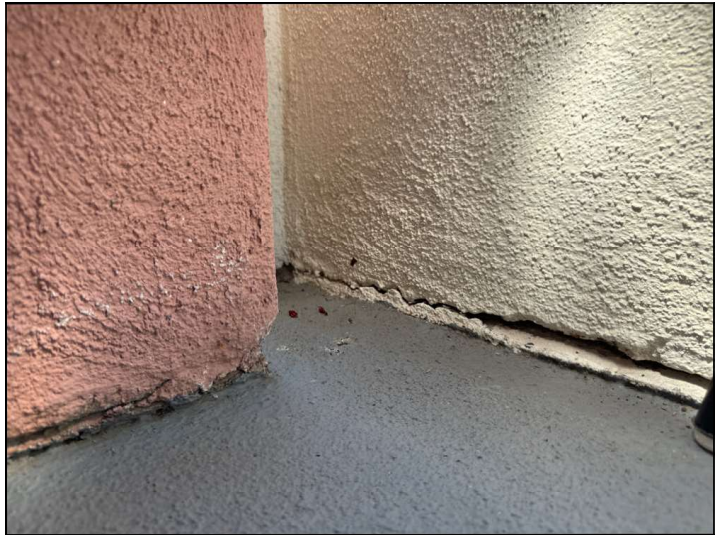
Flashings are not properly sealed at the floor-to-wall junction and may allow moisture penetration and damage.

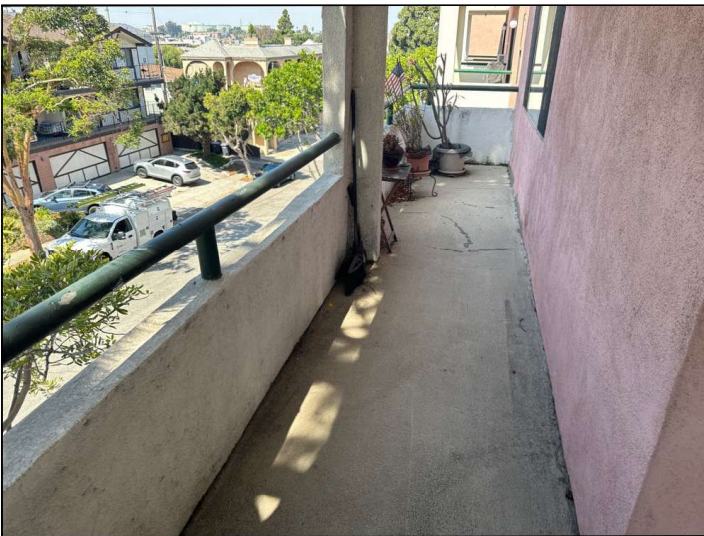
No visible structural problems were observed at the time of inspection.

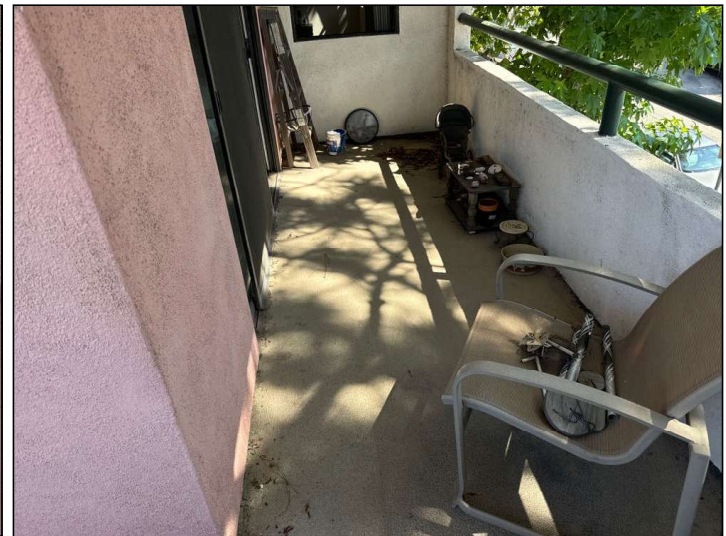
Balcony's underside is covered with wood or stucco and inaccessible for a full inspection. Further evaluation may be necessary. You may consider installing removable ventilation/inspection panels on the underside of the balcony to allow for ventilation and future required (every six years) inspections.

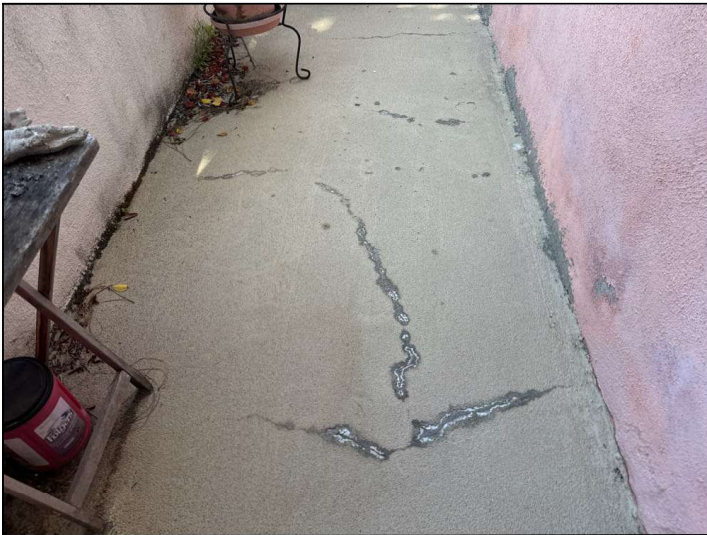
The Magnesite floor coating is damaged, cracked, bubbling or deteriorated. Repairs or resurfacing should be considered.

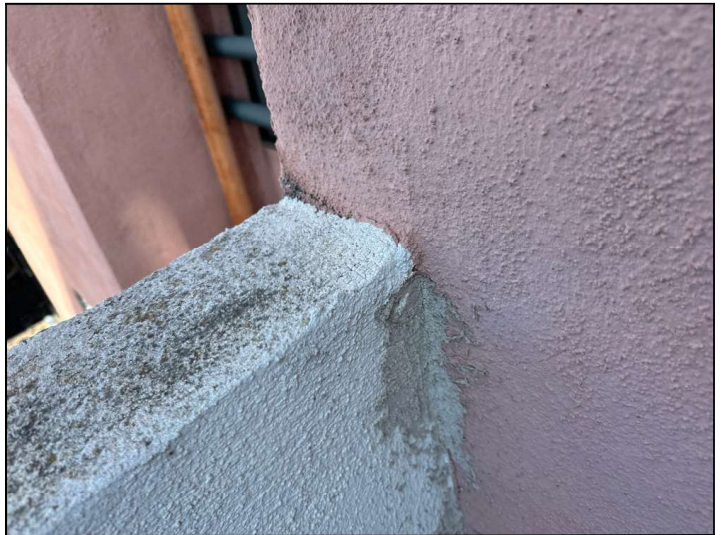
Flashings are not properly sealed at the stucco railing junction and may allow moisture penetration and damage.

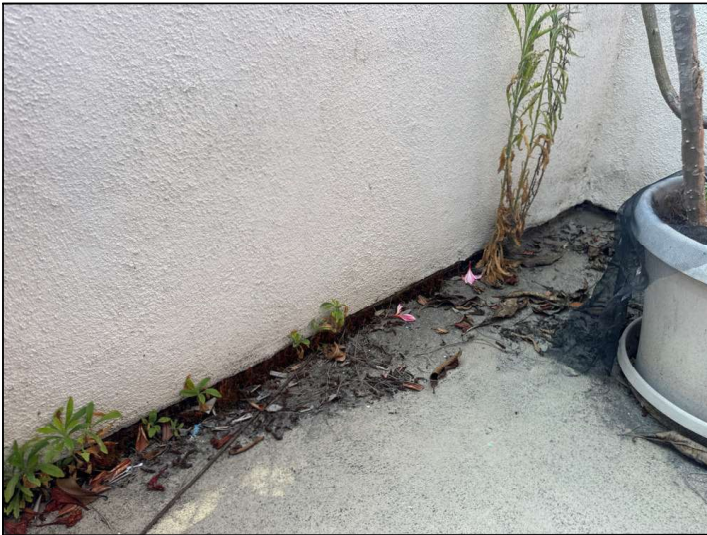
Improper floor drainage or evidence of pooling water was observed.

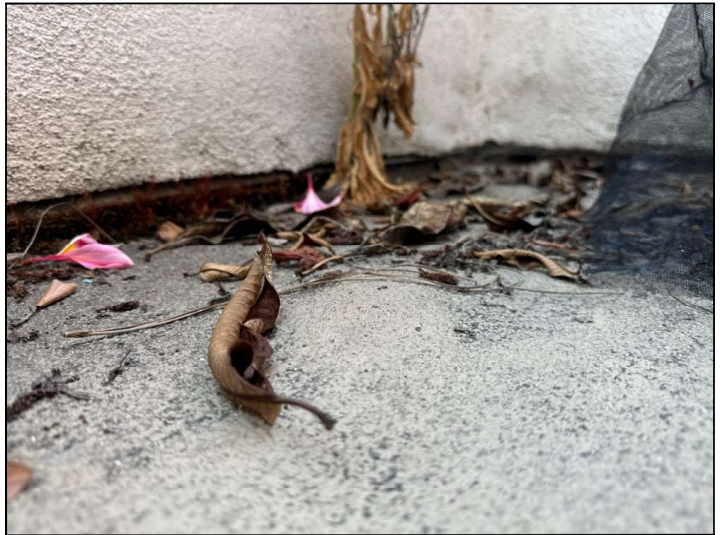
The floor drains at the balcony are blocked and do not provide adequate drainage.

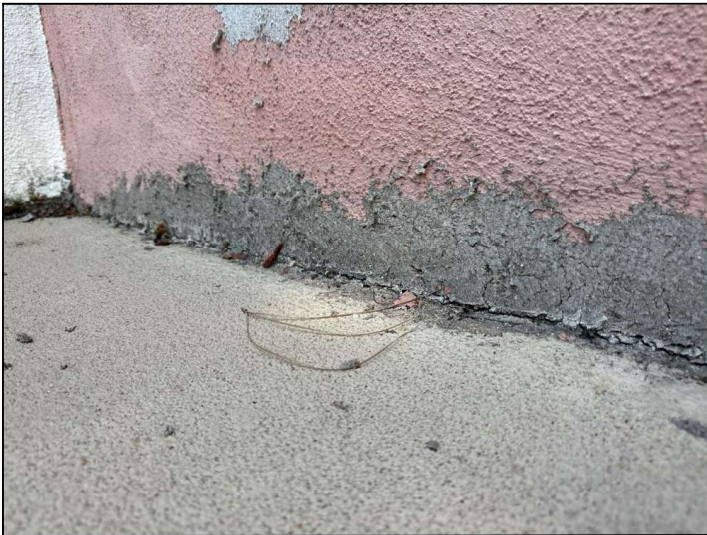
Flashings are not properly sealed at the floor-to-wall junction and may allow moisture penetration and damage.

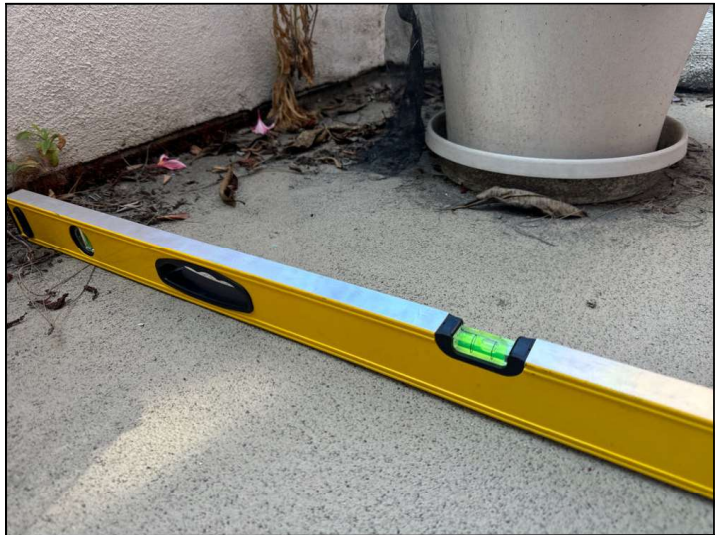
The Balcony floor is improperly sloped towards the structure instead of away. This will cause moisture to pool at the wall-to-floor junction or cause moisture to penetrate into the dwelling.

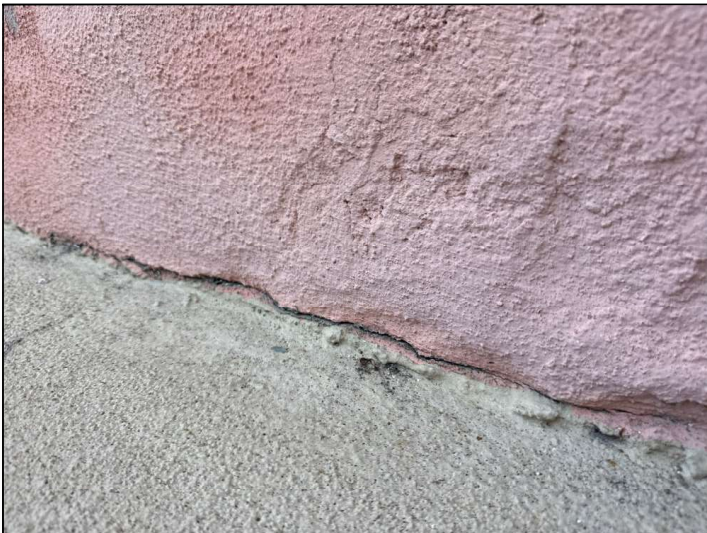
Flashings are not properly sealed at the floor-to-wall junction and may allow moisture penetration and damage.

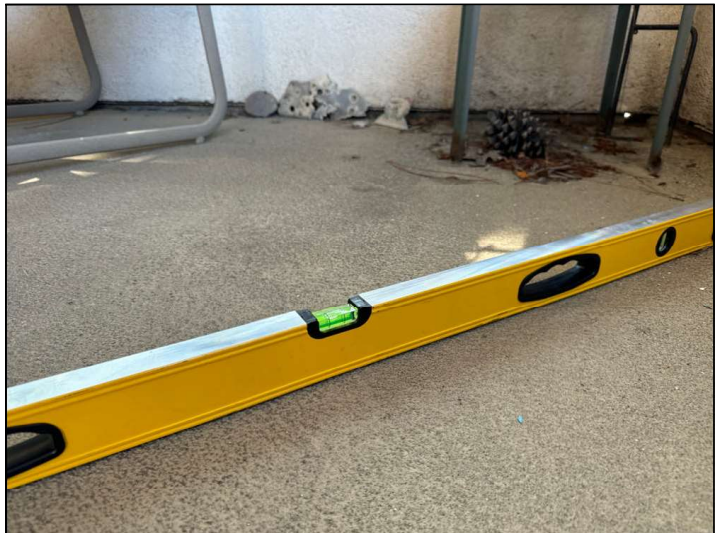
The Balcony floor is improperly sloped towards the structure instead of away. This will cause moisture to pool at the wall-to-floor junction or cause moisture to penetrate into the dwelling.

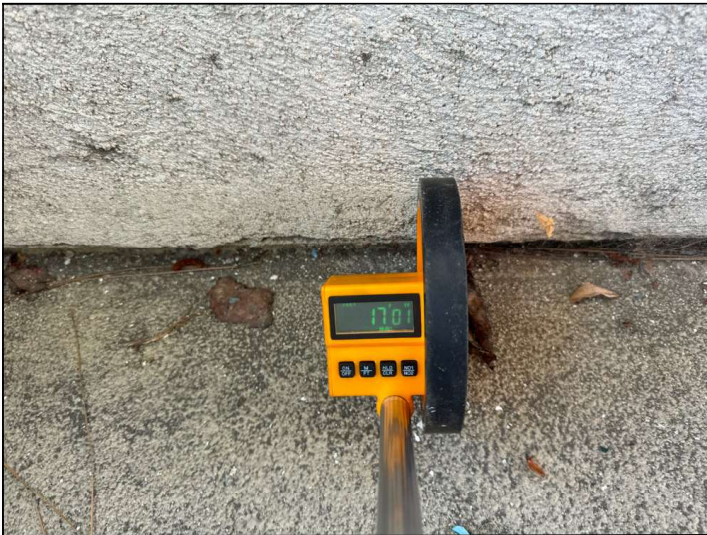
Measurement of balcony in one direction.

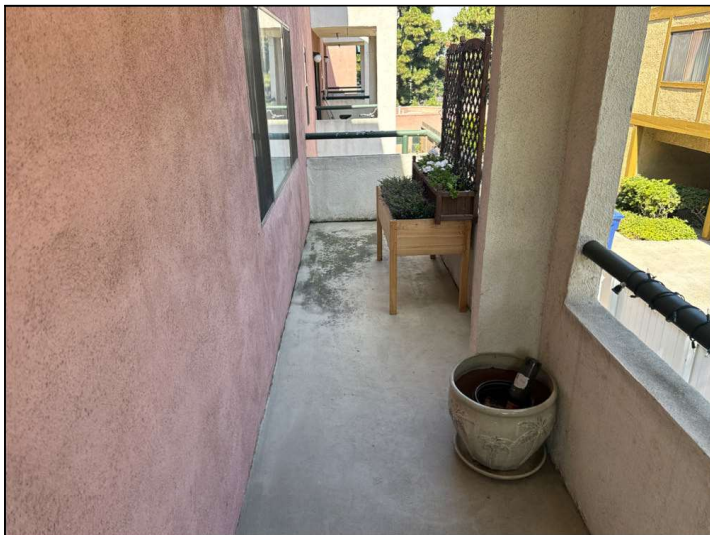
The Magnesite floor coating is damaged, cracked, bubbling or deteriorated. Repairs or resurfacing should be considered.

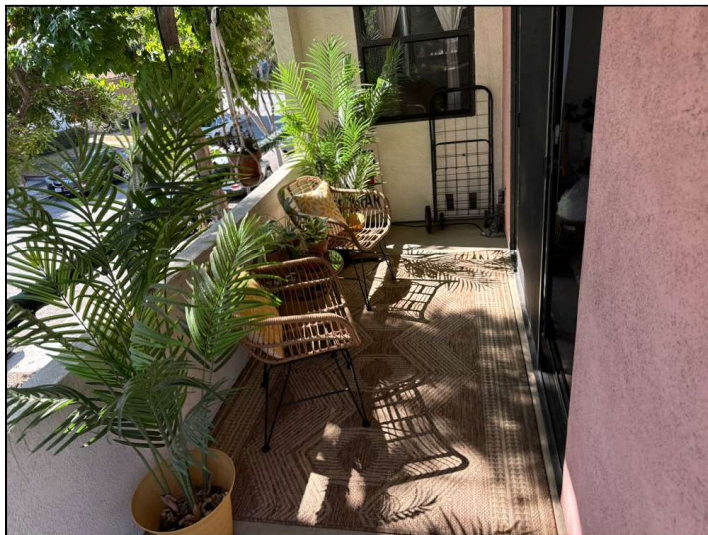
No visible structural problems were observed at the time of inspection.

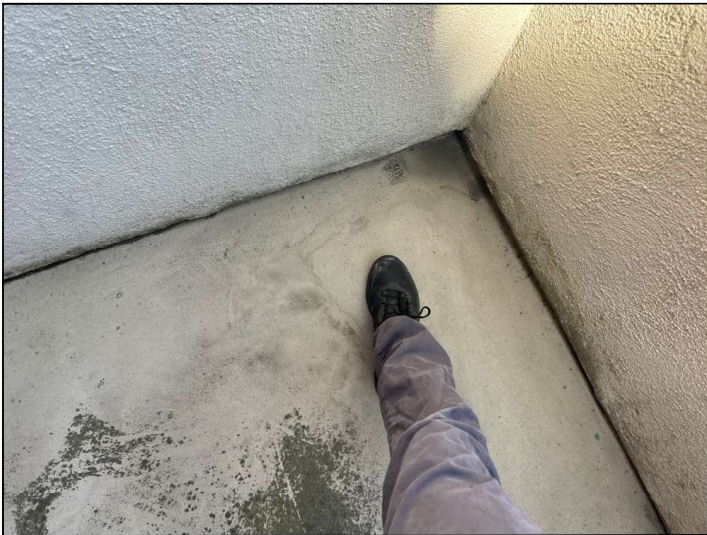
The Magnesite floor coating is damaged, cracked, bubbling or deteriorated. Repairs or resurfacing should be considered.

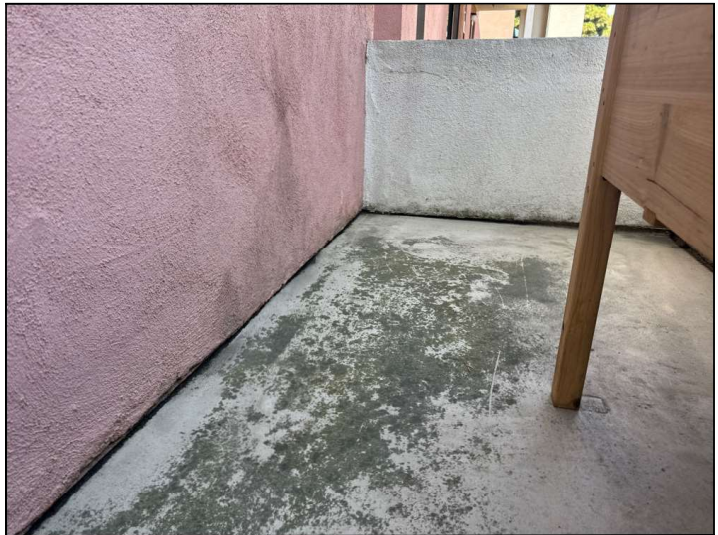
Improper floor drainage or evidence of pooling water was observed.

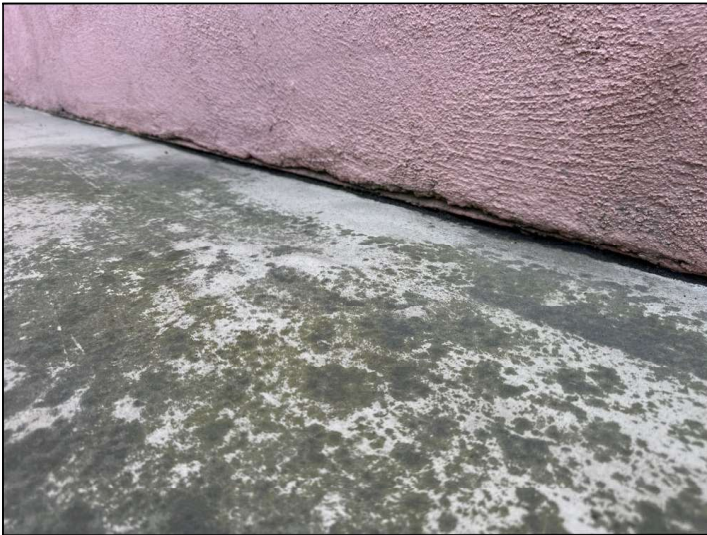
Evidence of moisture penetration was observed on the underside of the balcony, indicating moisture penetration on the floor above.

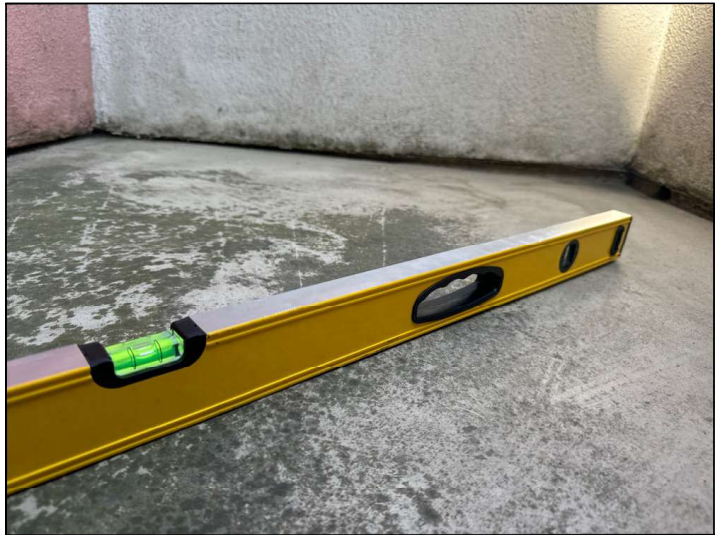
The Balcony floor is improperly sloped towards the structure instead of away. This will cause moisture to pool at the wall-to-floor junction or cause moisture to penetrate into the dwelling.

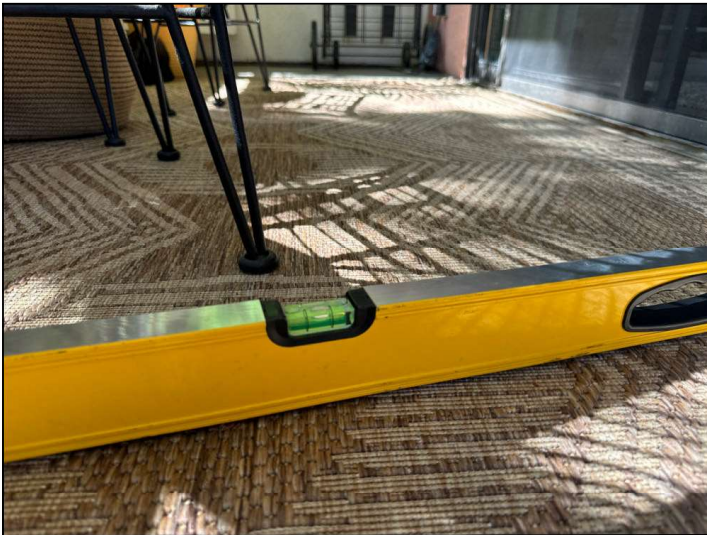
Improper floor drainage or evidence of pooling water was observed.

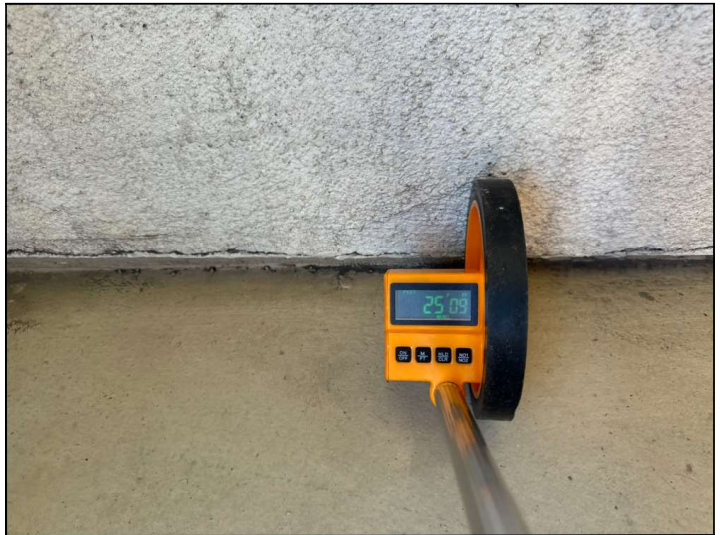
Measurement of balcony in one direction.

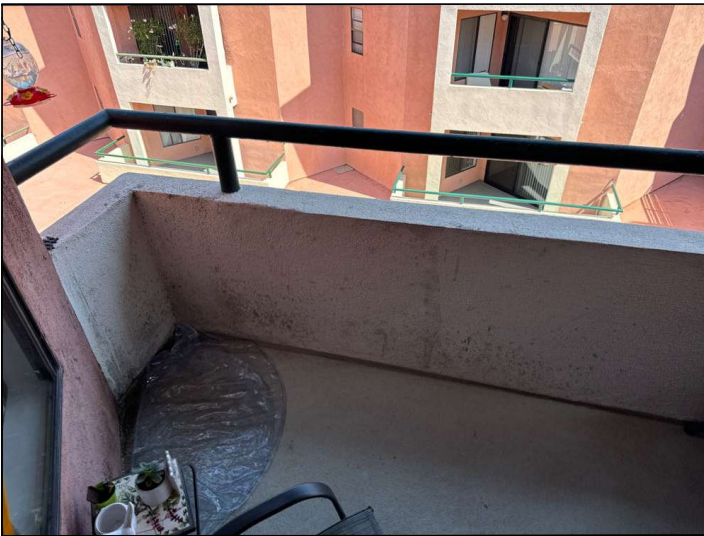
Balcony's underside is covered with wood or stucco and inaccessible for a full inspection. Further evaluation may be necessary. You may consider installing removable ventilation/inspection panels on the underside of the balcony to allow for ventilation and future required (every six years) inspections.

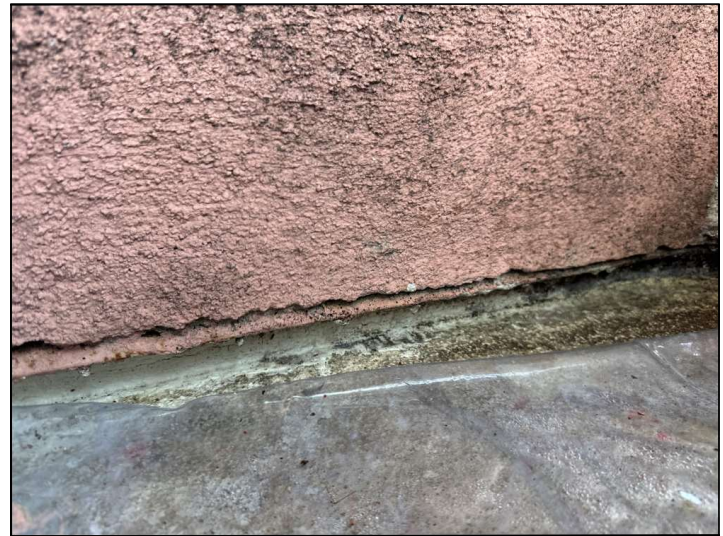
The Balcony floor is improperly sloped towards the structure instead of away. This will cause moisture to pool at the wall-to-floor junction or cause moisture to penetrate into the dwelling.

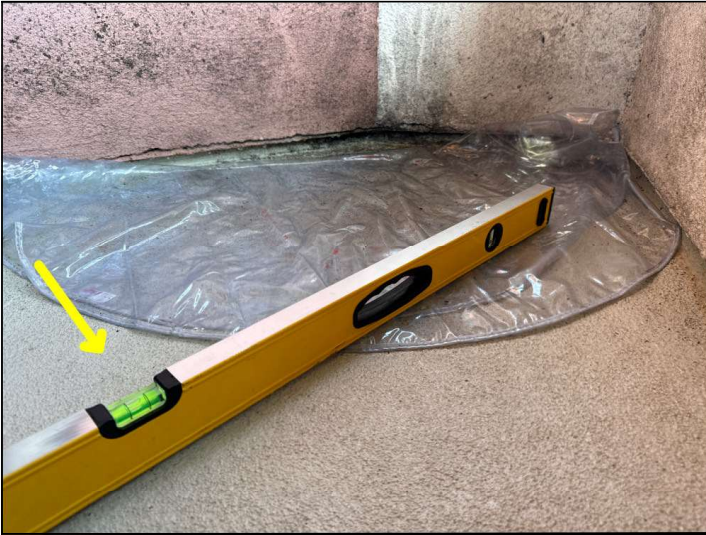
Improper floor drainage or evidence of pooling water was observed.

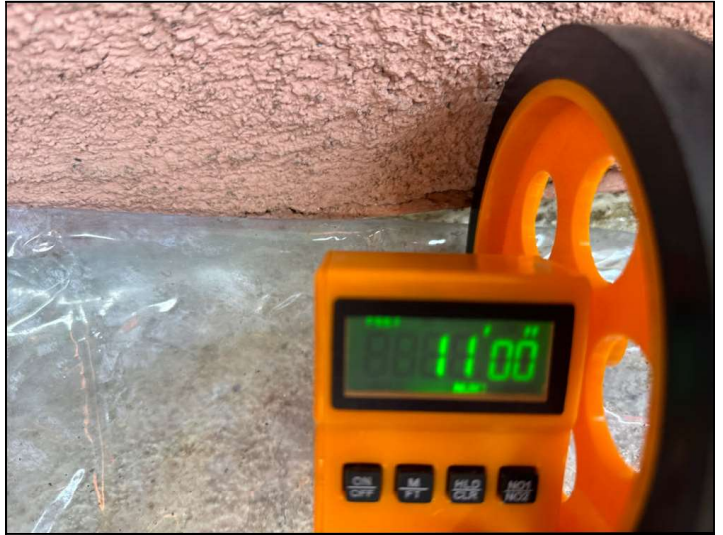
Measurement of balcony in one direction.

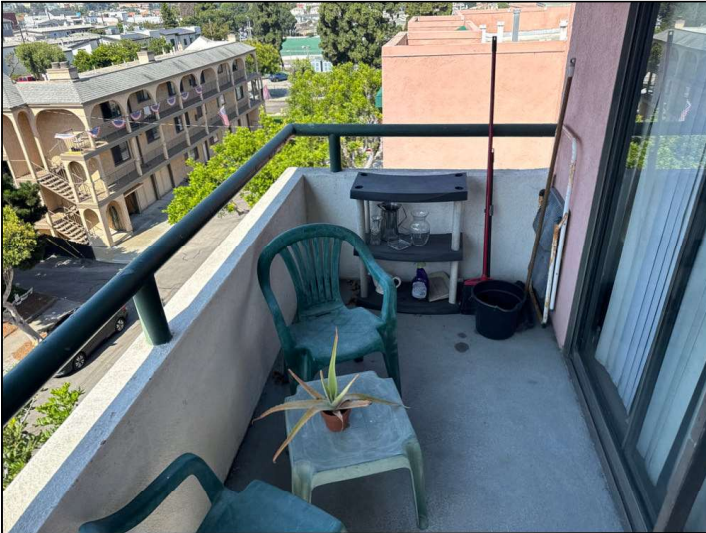
Balcony's underside is covered with wood or stucco and inaccessible for a full inspection. Further evaluation may be necessary. You may consider installing removable ventilation/inspection panels on the underside of the balcony to allow for ventilation and future required (every six years) inspections.

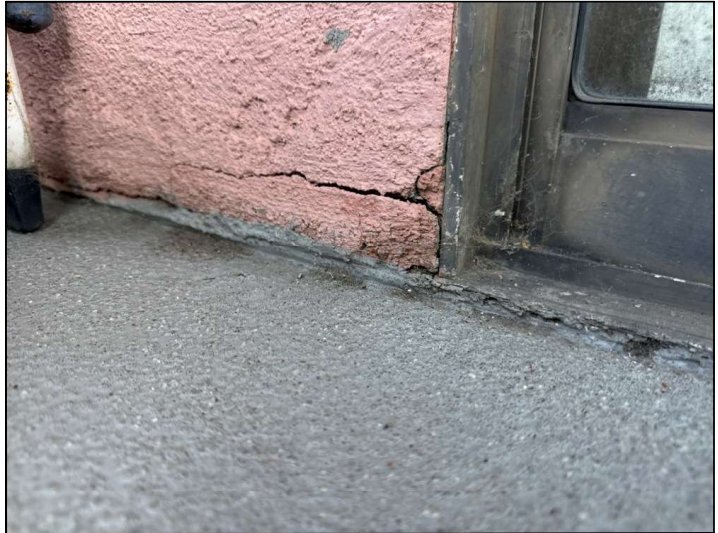
The Door frame/threshold is not properly sealed at the floor junction and may allow moisture penetration and damage.

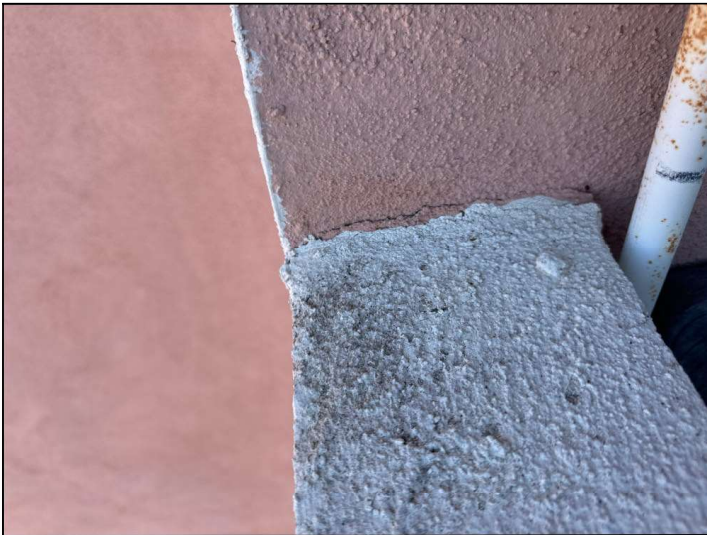
Flashings are not properly sealed at the stucco railing junction and may allow moisture penetration and damage.

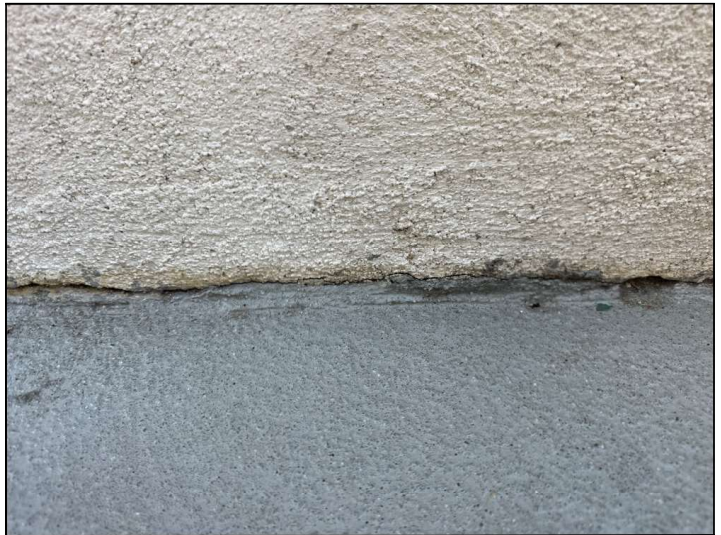
Flashings are not properly sealed at the floor-to-wall junction and may allow moisture penetration and damage.

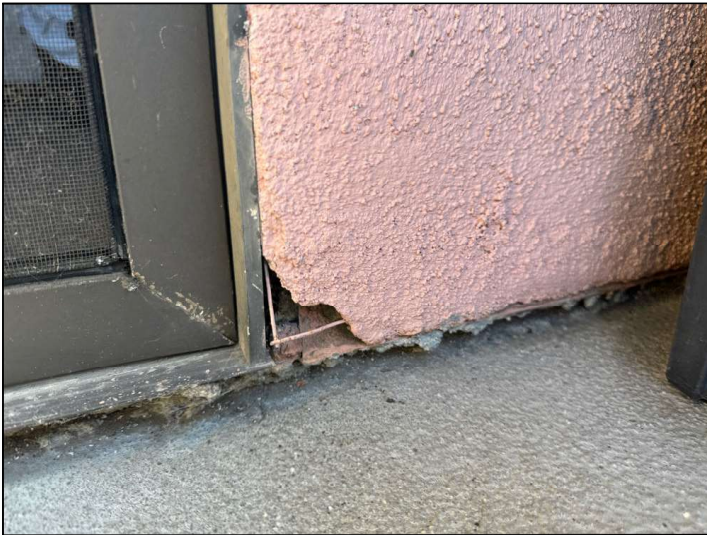
Flashings are not properly sealed at the floor-to-wall junction and may allow moisture penetration and damage.

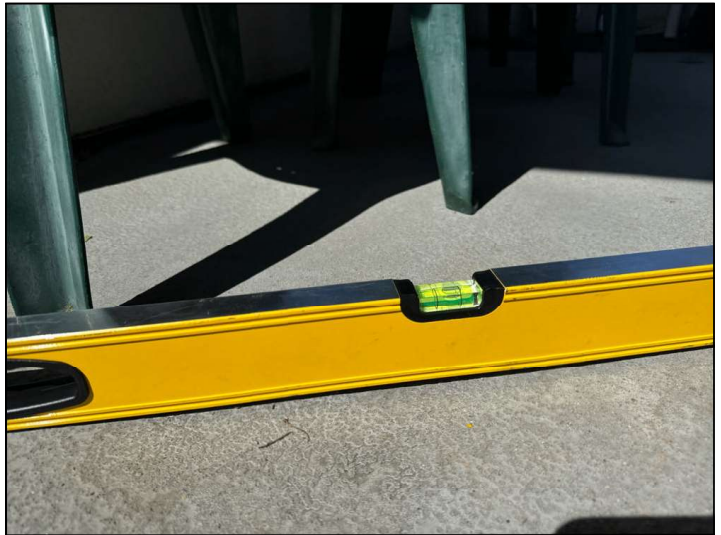
Slope for drainages appears adequate.

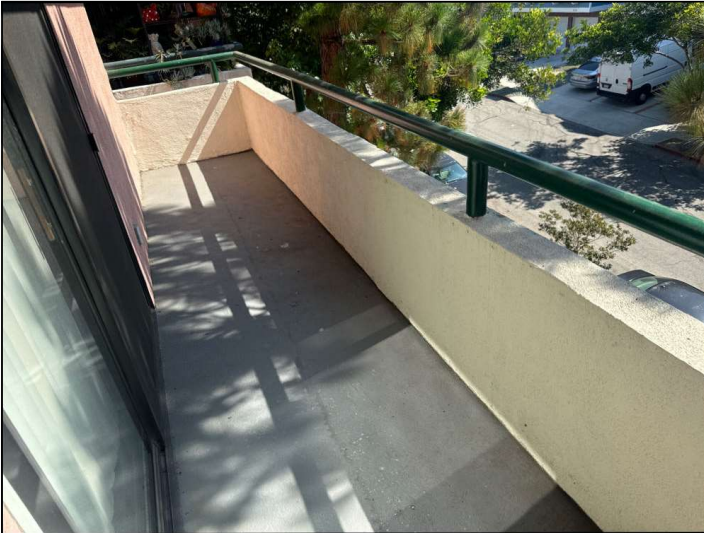
No visible structural problems were observed at the time of inspection.

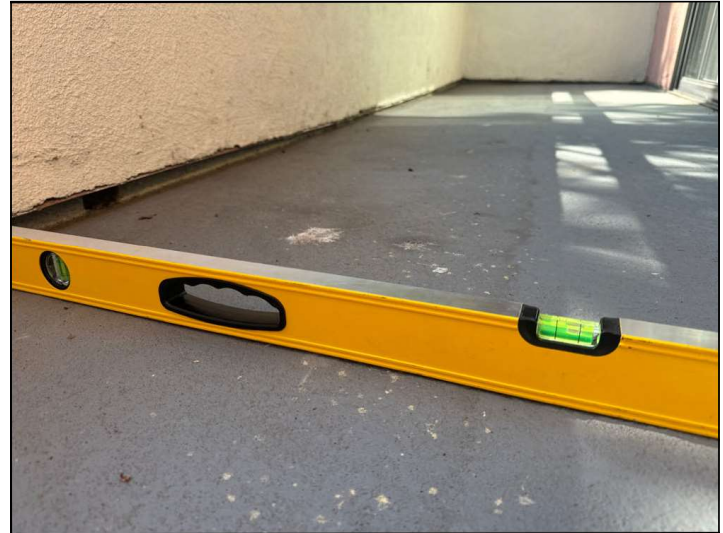
Slope for drainage appears adequate.

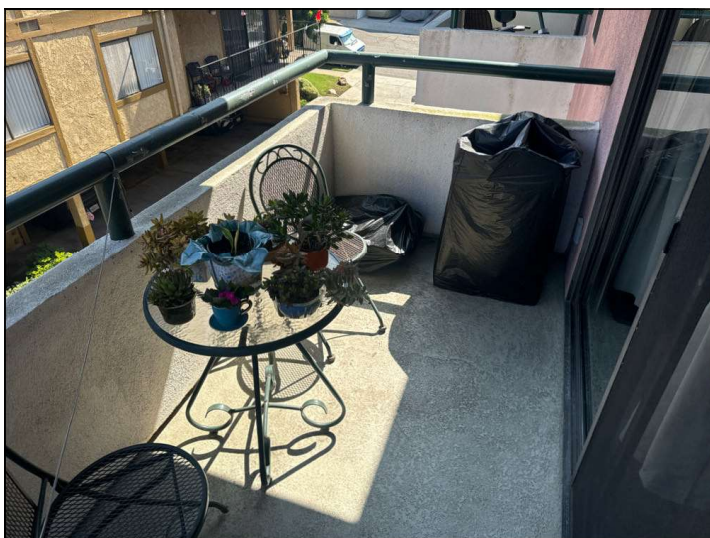
Unable to fully view the balcony due to occupants' belongings. The inspector did not move the occupants' belongings during the inspection. Further evaluation is recommended.

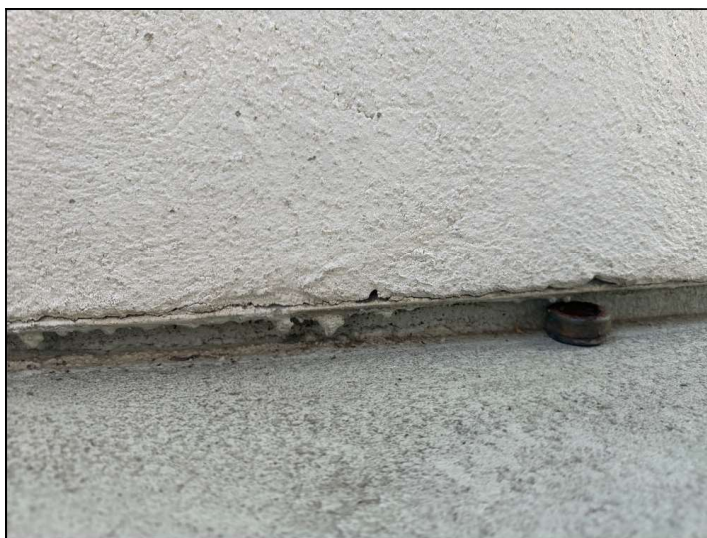
Flashings are not properly sealed at the floor-to-wall junction and may allow moisture penetration and damage.
