**REGULAR MEETING OF THE
Board of Directors of the
El Segundo Senior Citizens Housing Corporation
AGENDA
In-Person Meeting**

MEETING DATE: Wednesday, August 28, 2024

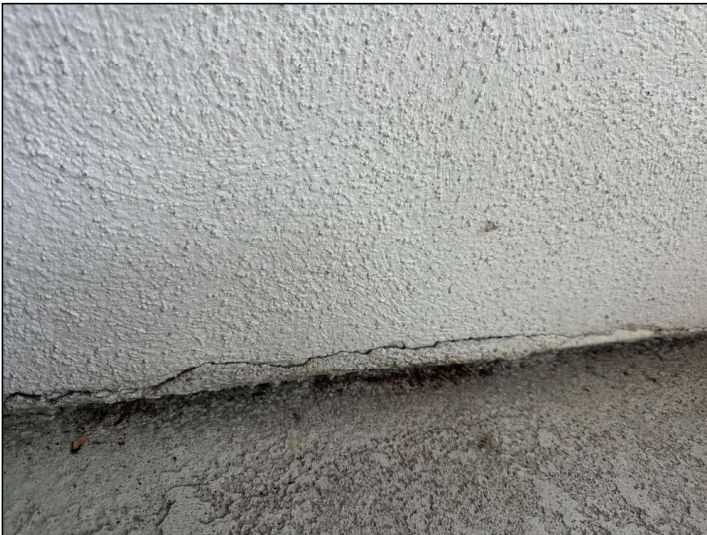
Flashings are not properly sealed at the floor-to-wall junction and may allow moisture penetration and damage.

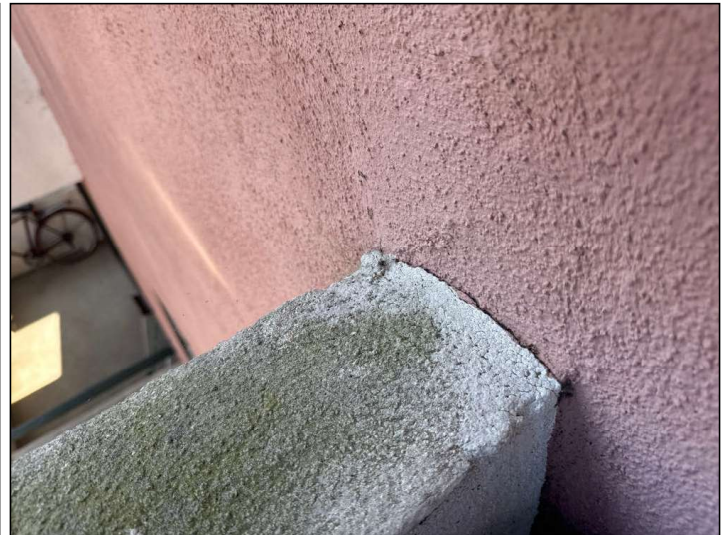
Flashings are not properly sealed at the stucco railing junction and may allow moisture penetration and damage.

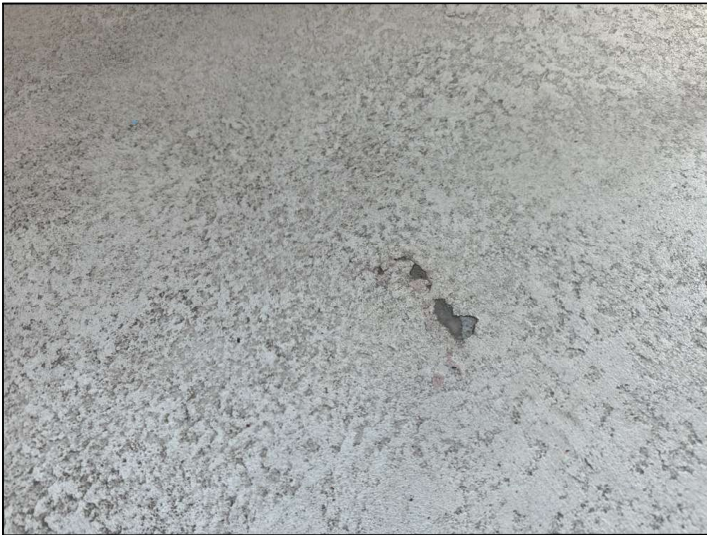
The Magnesite floor coating is damaged, cracked, bubbling or deteriorated. Repairs or resurfacing should be considered.

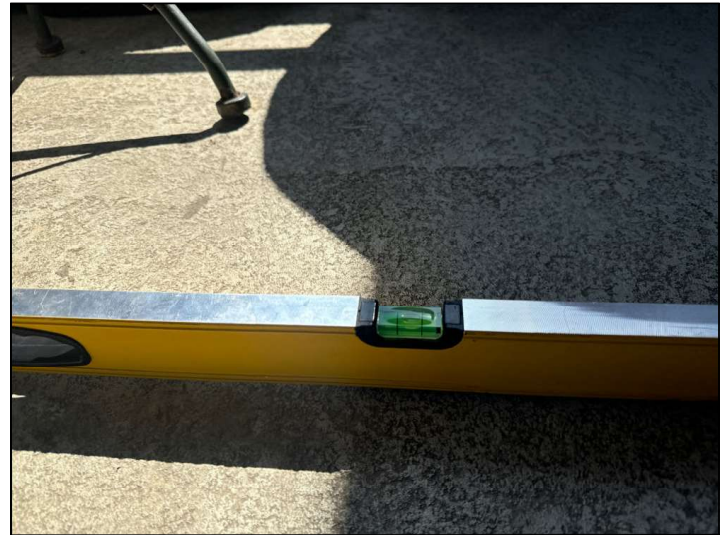
Slope for drainage appears adequate.

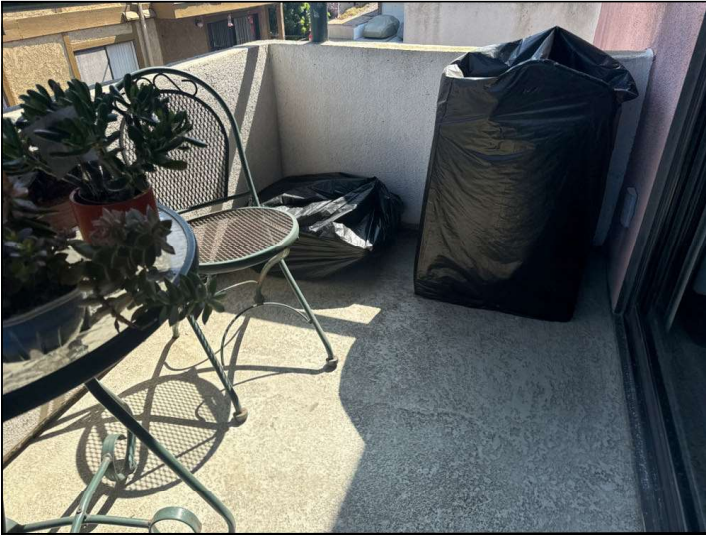
The Magnesite floor coating is damaged, cracked, bubbling or deteriorated. Repairs or resurfacing should be considered.

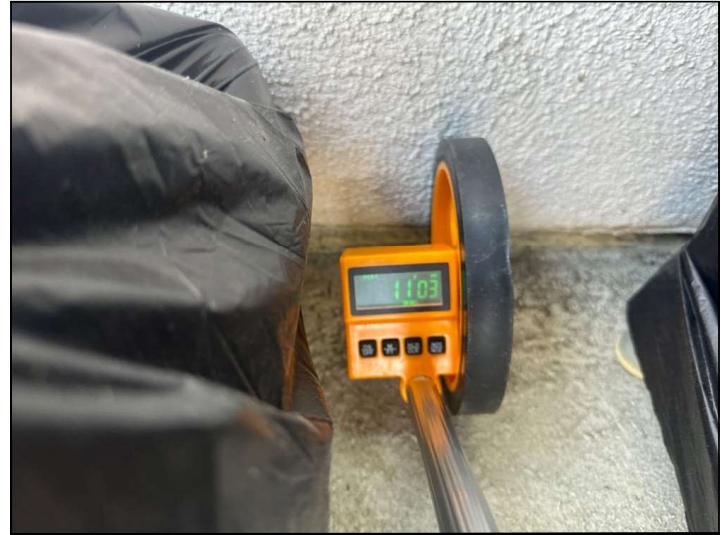
Measurement of balcony in one direction.

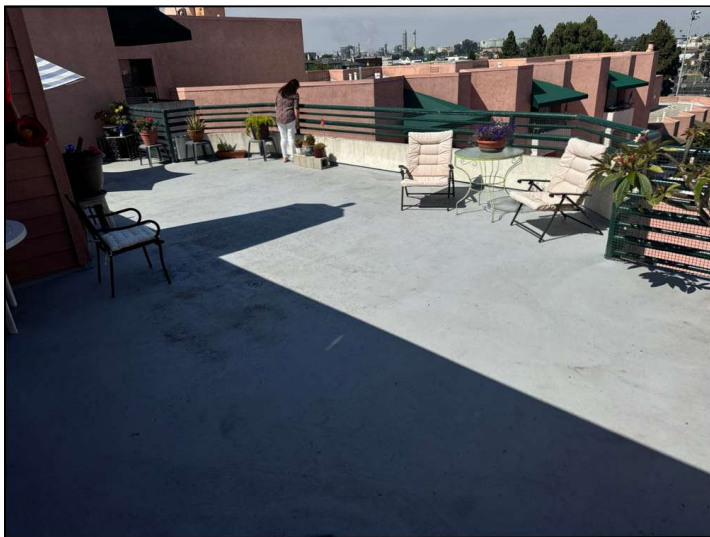
No visible structural problems were observed at the time of inspection.

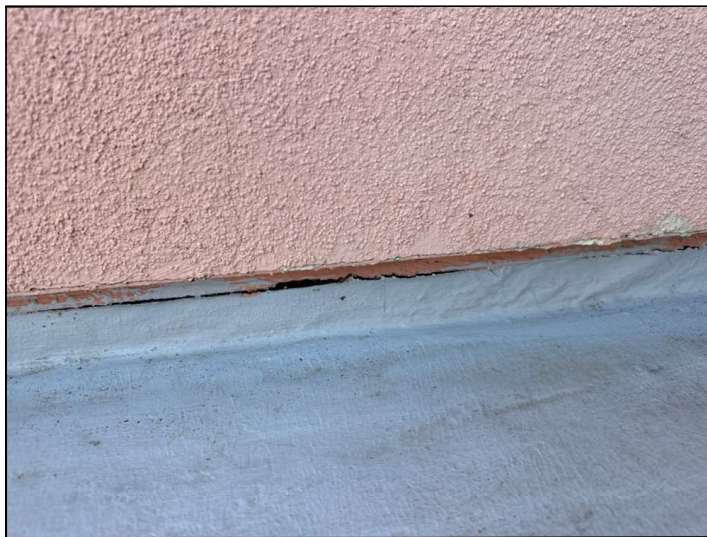
Flashings are not properly sealed at the floor-to-wall junction and may allow moisture penetration and damage.

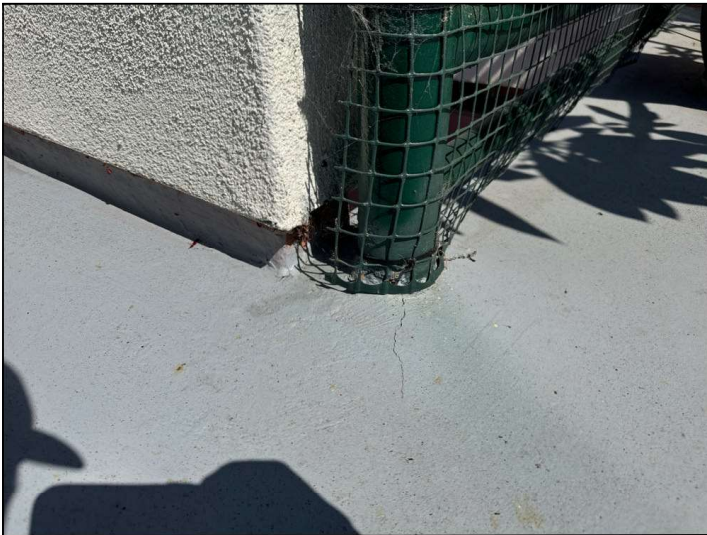
Cracks observed are moderate and may allow moisture penetration and damage.

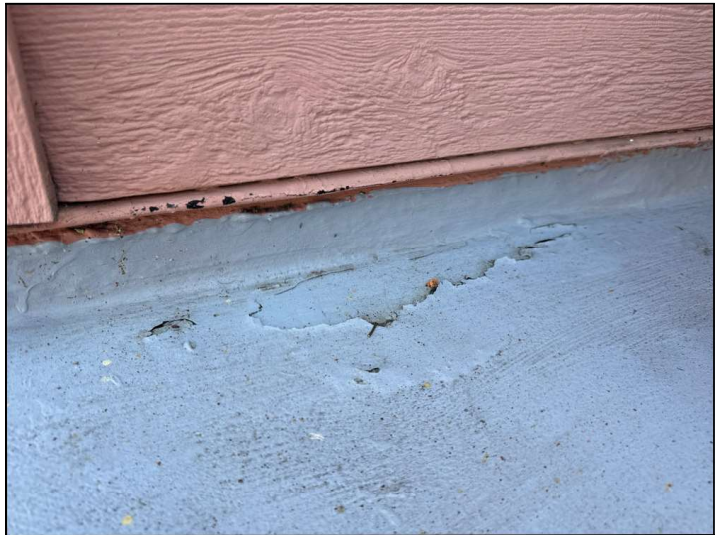
Cracks observed are moderate and may allow moisture penetration and damage.

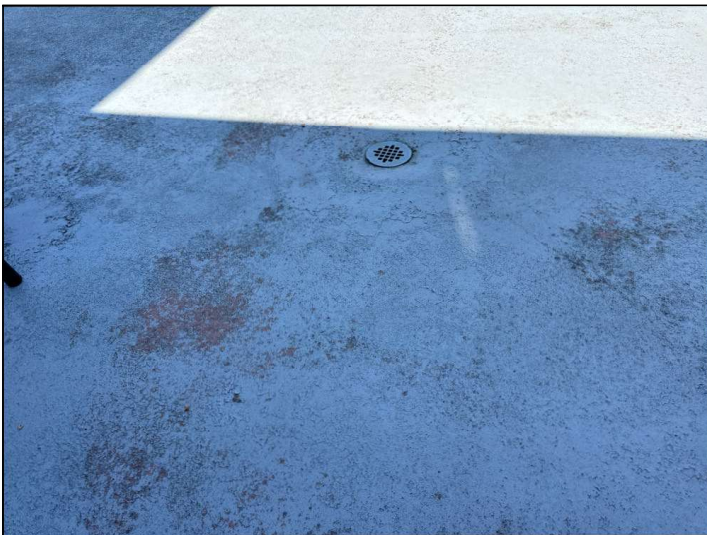
The Magnesite floor coating is damaged, cracked, bubbling or deteriorated. Repairs or resurfacing should be considered.

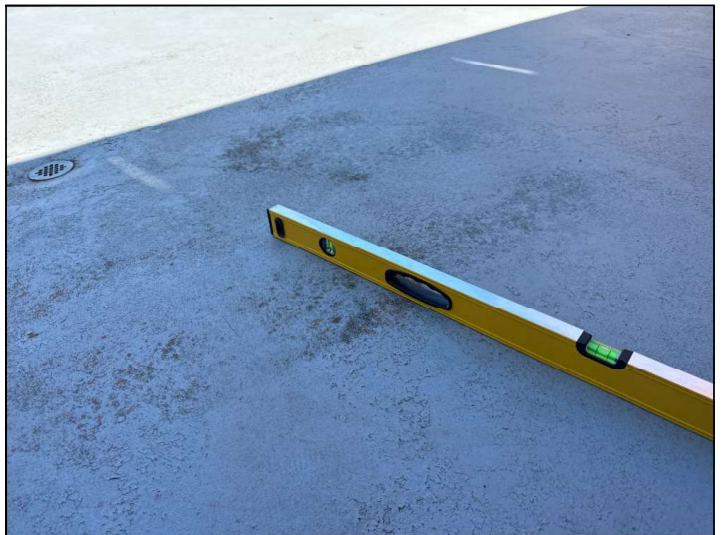
Slope for drainage appears adequate.

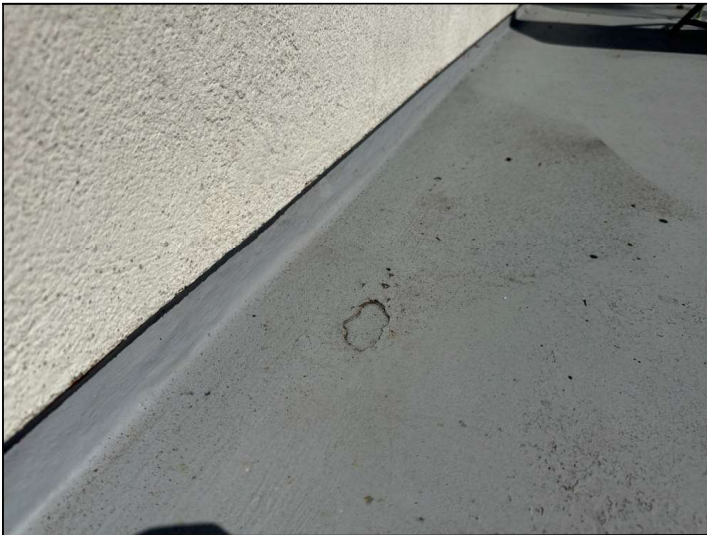
The Magnesite floor coating is damaged, cracked, bubbling or deteriorated. Repairs or resurfacing should be considered.

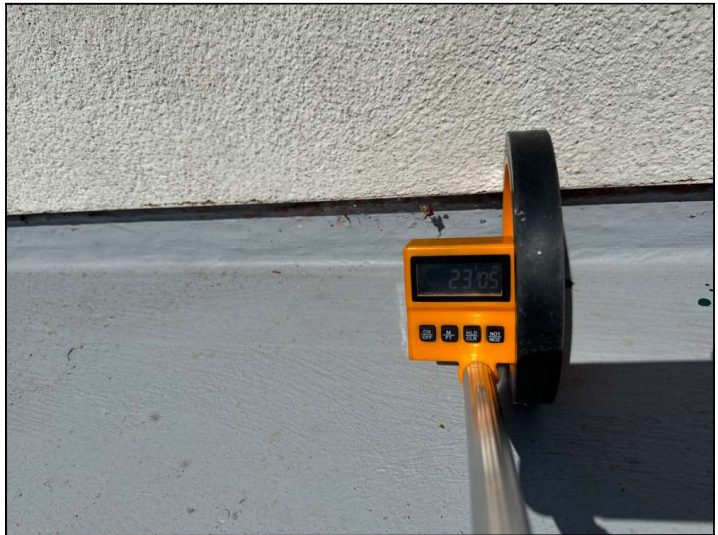
Measurement of balcony in one direction.

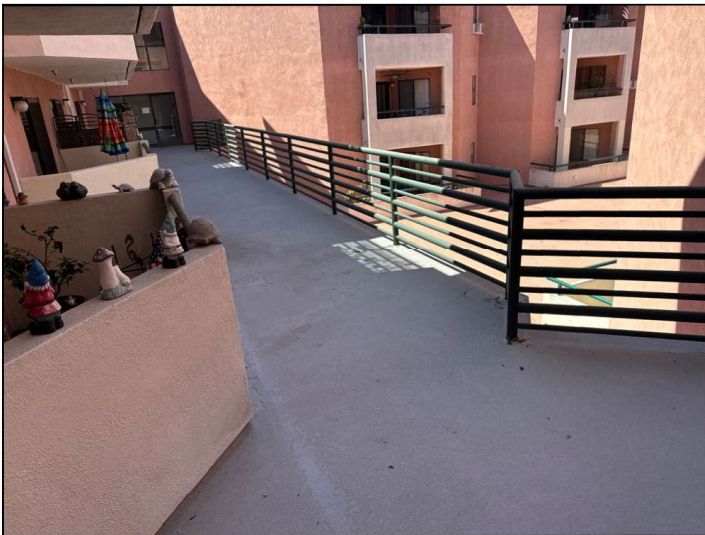
No visible structural problems were observed at the time of inspection.

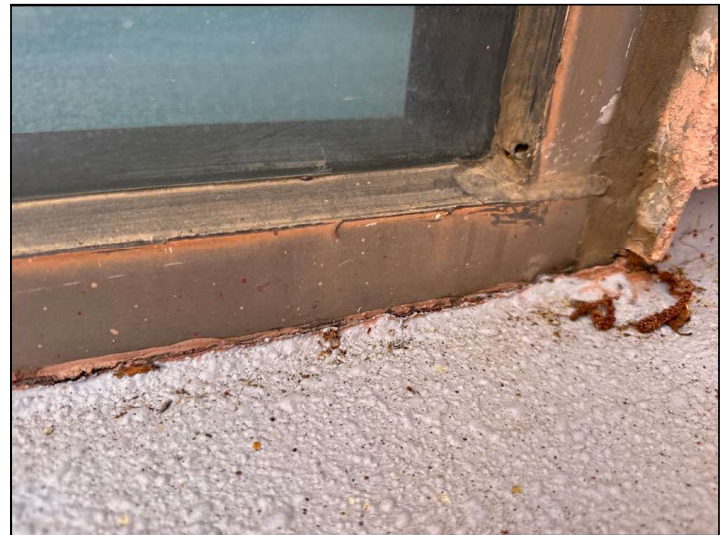
The Door frame/threshold is not properly sealed at the floor junction and may allow moisture penetration and damage.

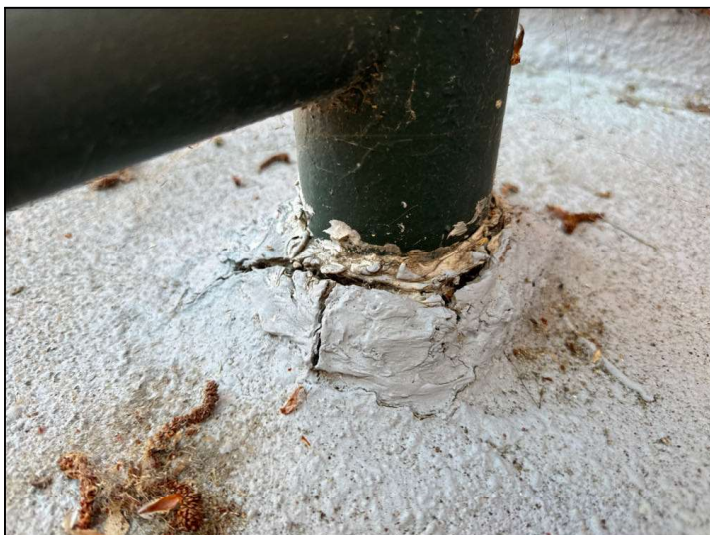
Flashings at the floor-to-railing junction are not properly sealed, which may allow moisture penetration and damage.

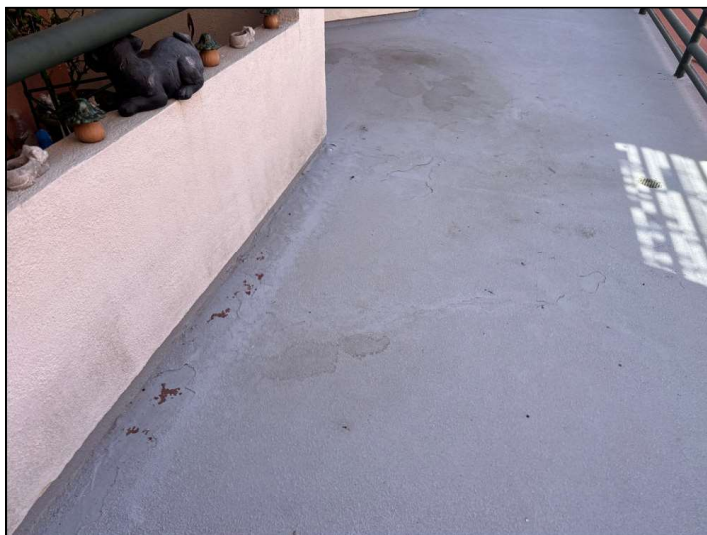
Improper floor drainage or evidence of pooling water was observed.

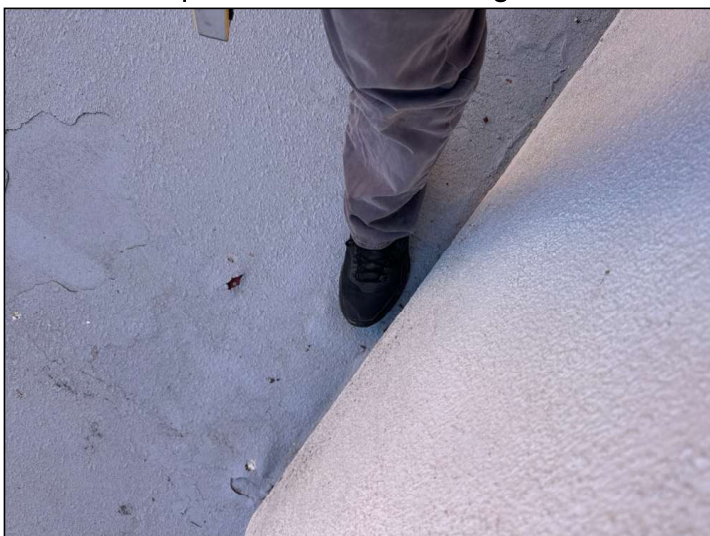
The Magnesite floor coating is damaged, cracked, bubbling or deteriorated. Repairs or resurfacing should be considered.

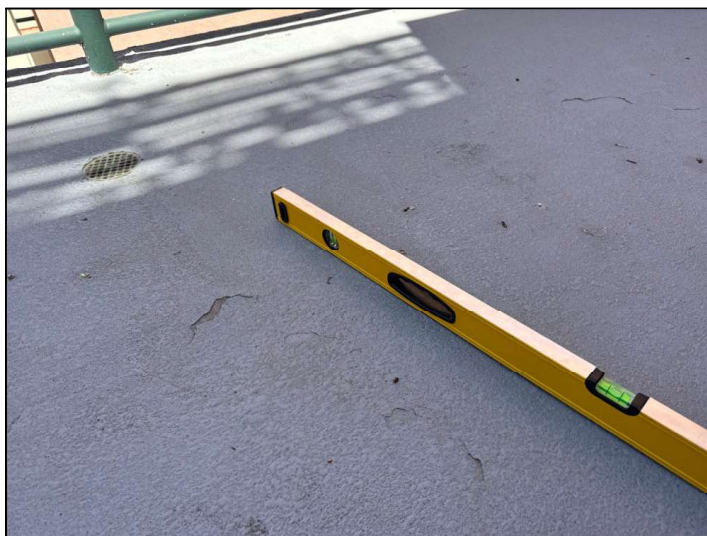
Improper floor drainage or evidence of pooling water was observed.

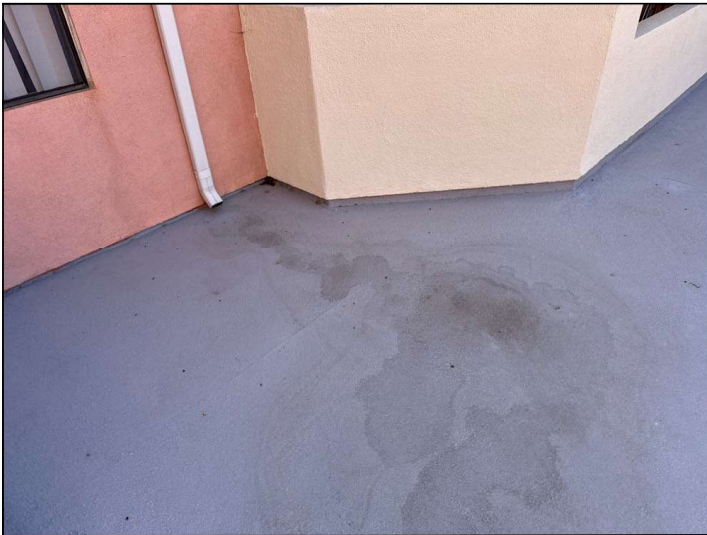
Improper floor drainage or evidence of pooling water was observed.

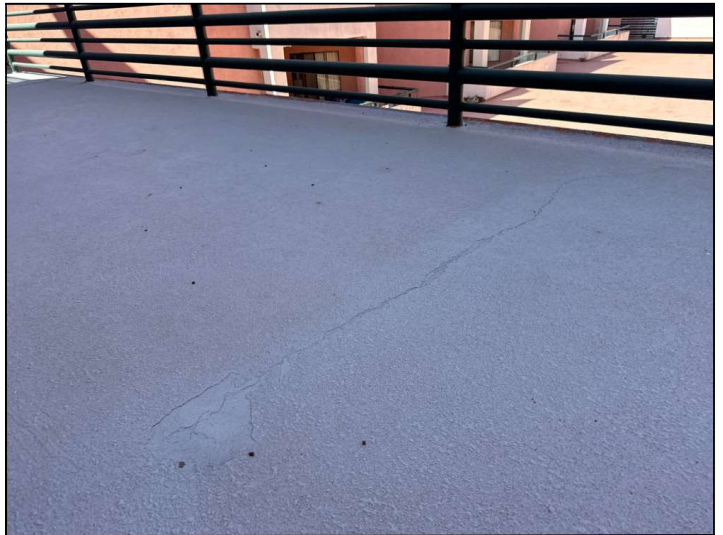
Cracks observed are moderate and may allow moisture penetration and damage.

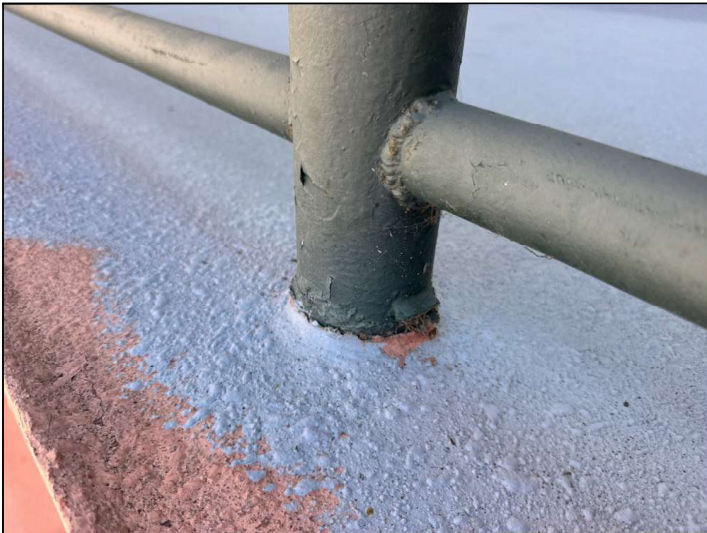
Flashings at the floor-to-railing junction are not properly sealed, which may allow moisture penetration and damage.

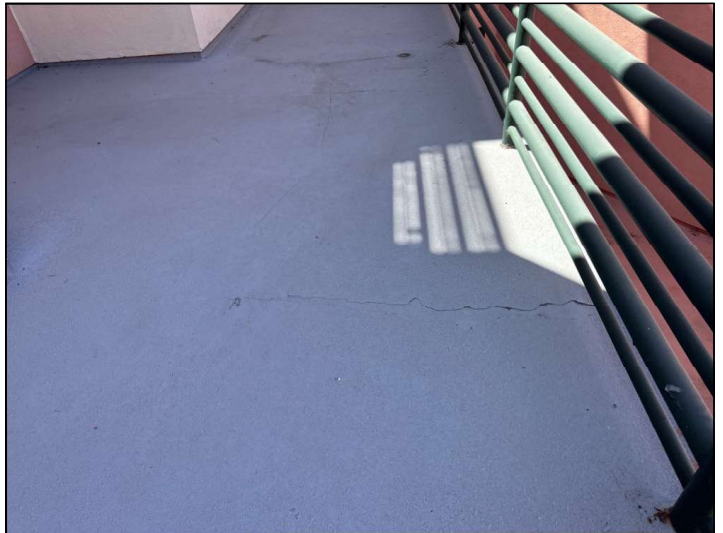
Cracks noted are significant and may allow moisture penetration and damage.

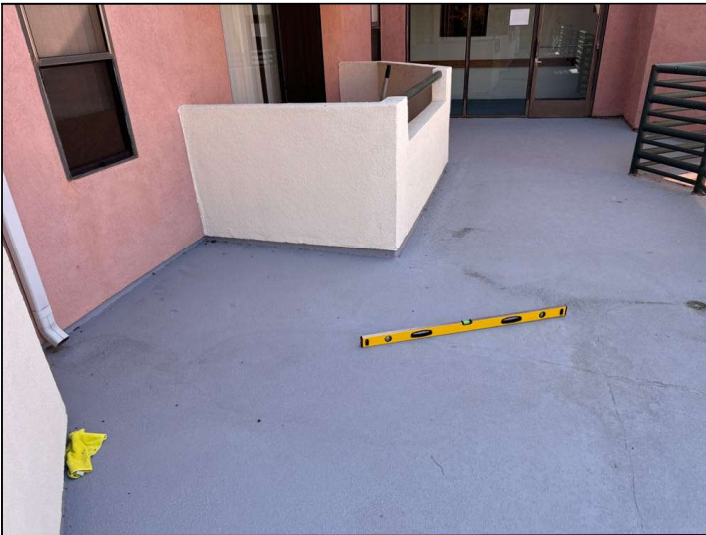
The Balcony floor is improperly sloped towards the structure instead of away. This will cause moisture to pool at the wall-to-floor junction or cause moisture to penetrate into the dwelling.

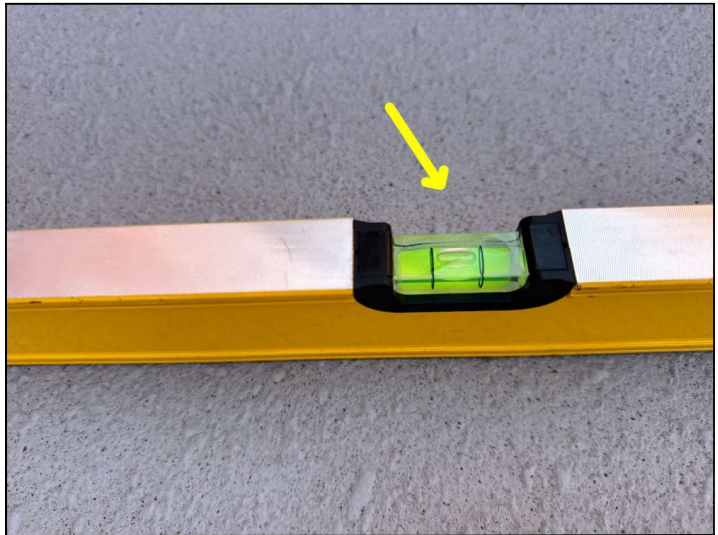
The Balcony floor is improperly sloped towards the structure instead of away. This will cause moisture to pool at the wall-to-floor junction or cause moisture to penetrate into the dwelling.

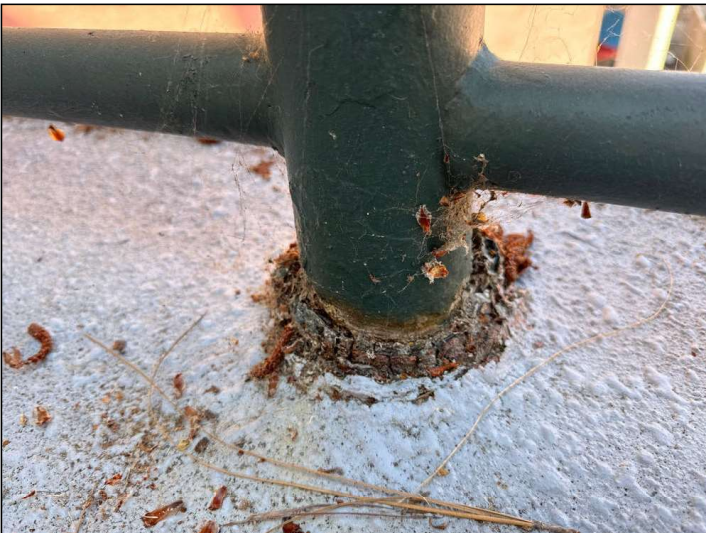
Flashings at the floor-to-railing junction are not properly sealed, which may allow moisture penetration and damage.

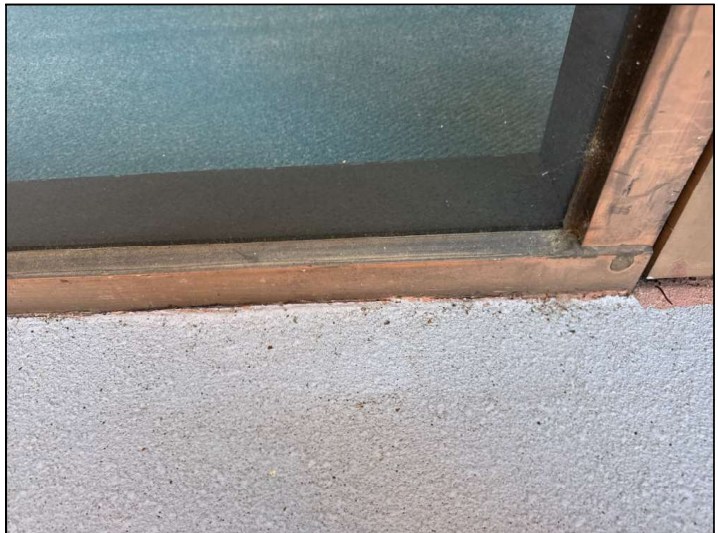
The Door frame/threshold is not properly sealed at the floor junction and may allow moisture penetration and damage.

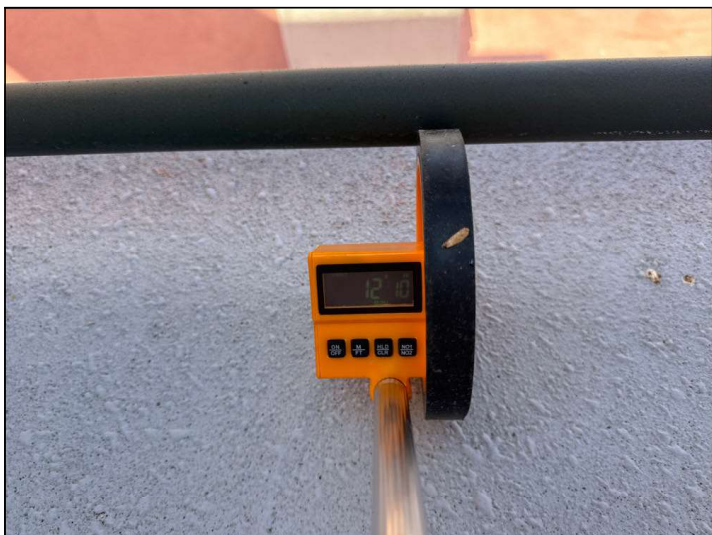
Measurement of balcony in one direction.

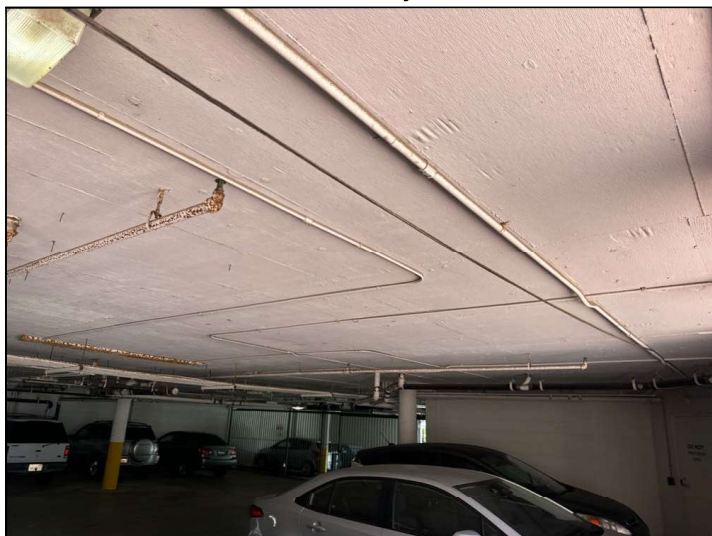
No visible structural problems were observed at the time of inspection.

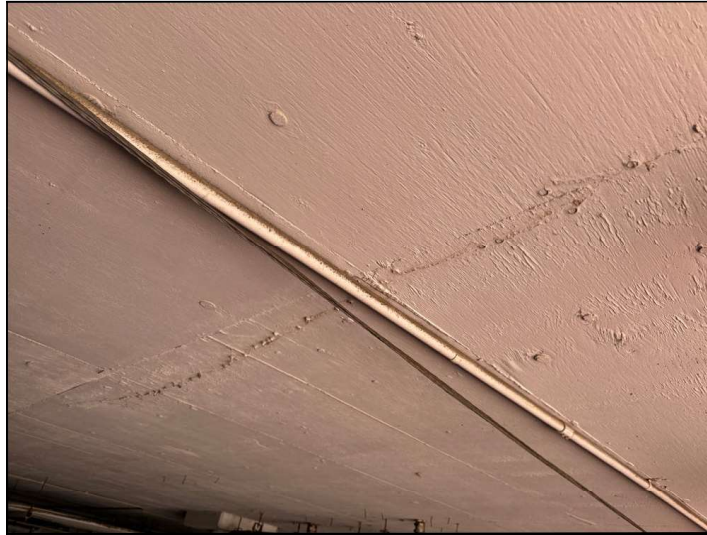
Evidence of moisture penetration was observed on the underside of the balcony, indicating moisture penetration on the floor above.

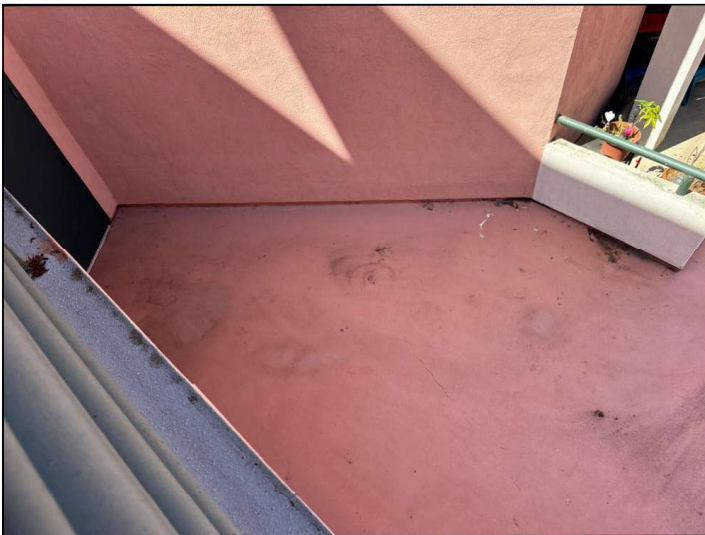
Improper floor drainage or evidence of pooling water was observed.

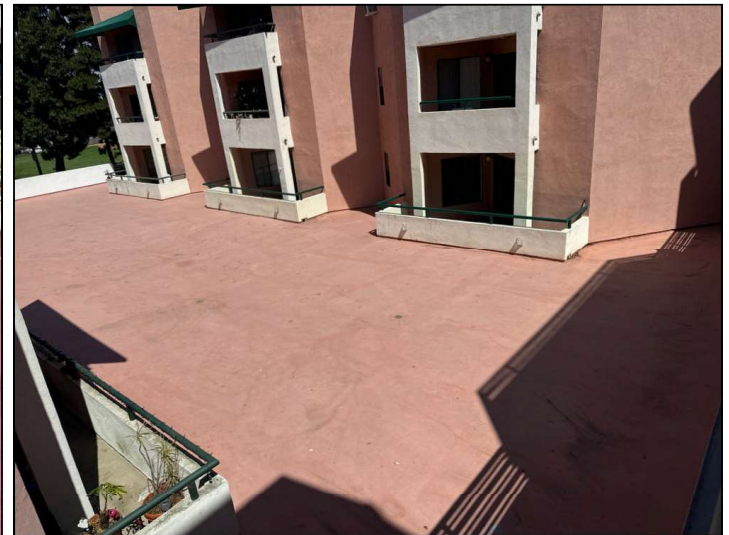
No visible structural problems were observed at the time of inspection.

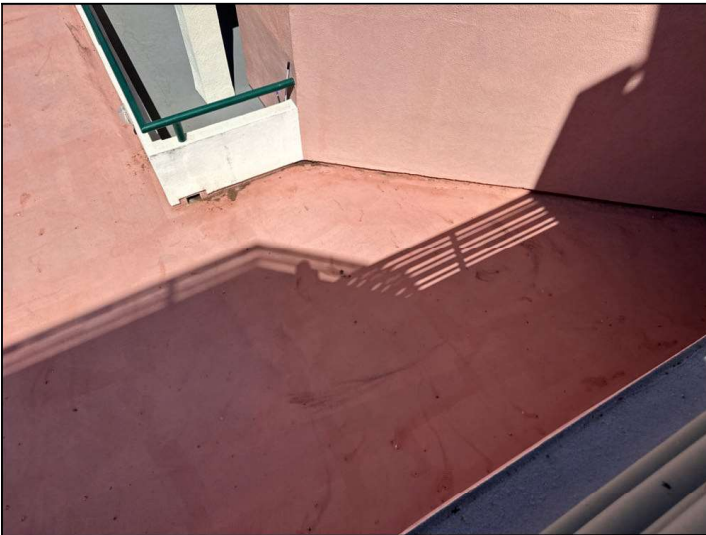
The Magnesite floor coating is damaged, cracked, bubbling or deteriorated. Repairs or resurfacing should be considered.

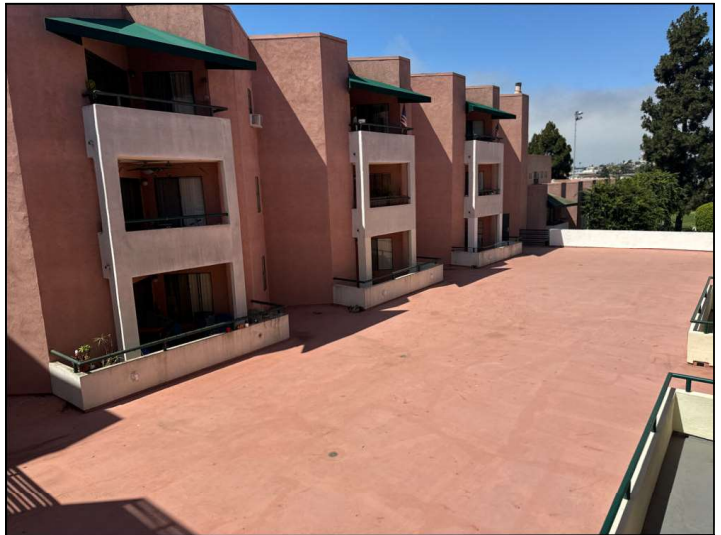
No visible structural problems were observed at the time of inspection.

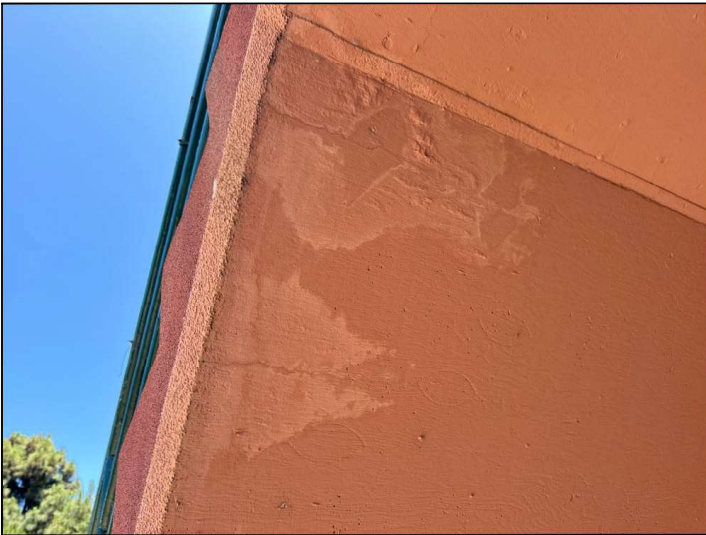
Moisture stains and or damage were observed on the underside of the balcony. This is an indication of prolonged moisture penetration, which could have affected the balcony structure.

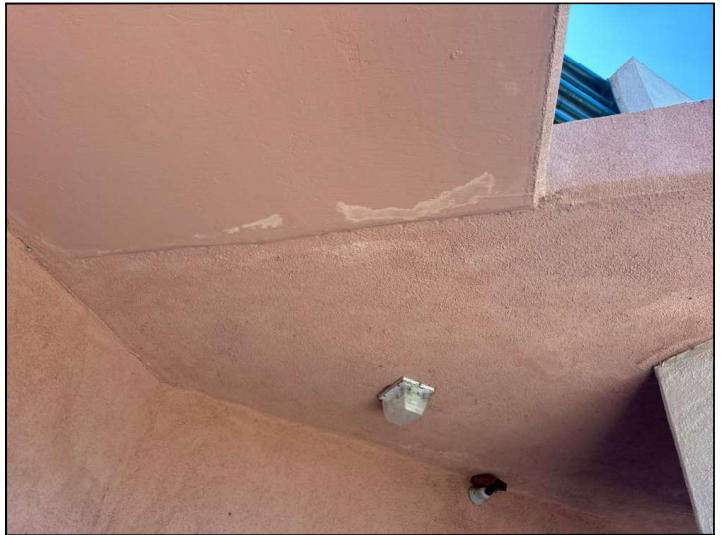
Evidence of moisture penetration was observed on the underside of the balcony, indicating moisture penetration on the floor above.

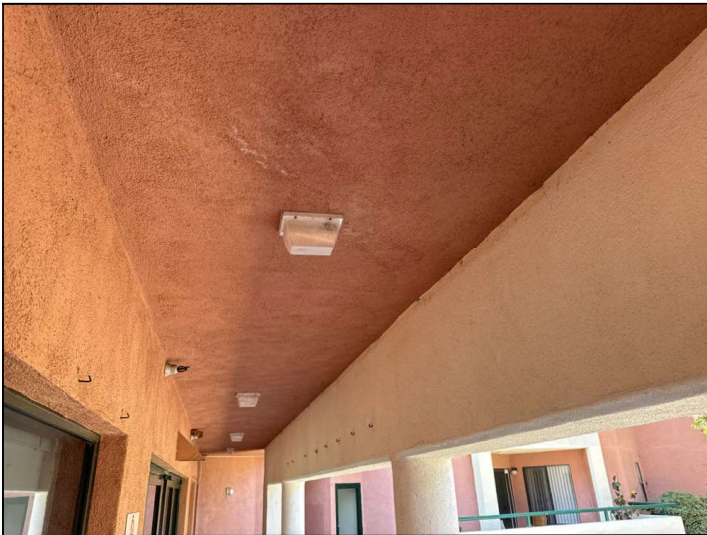
You may consider installing removable ventilation/inspection panels on the underside of the balcony to allow for ventilation and future required (every six years) inspections.

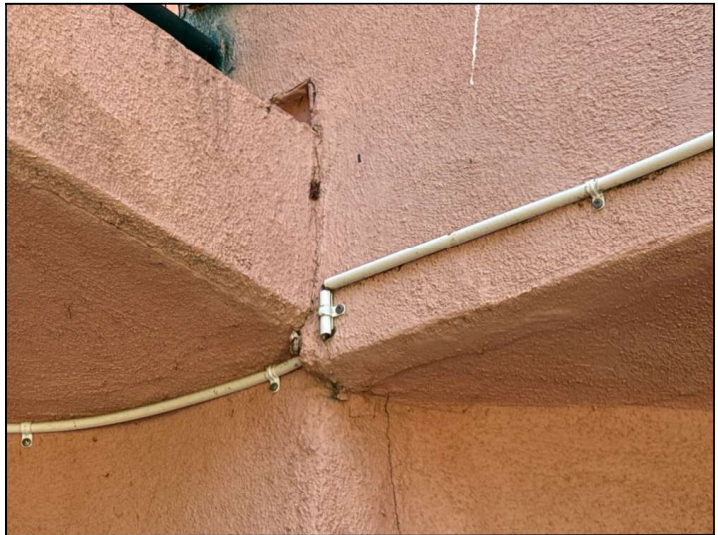
Flashings are not properly sealed at the floor-to-wall junction and may allow moisture penetration and damage.

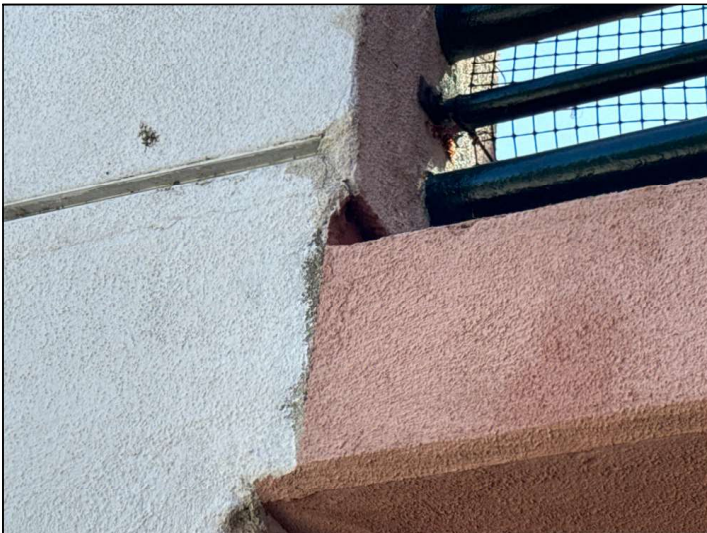
Flashings are not properly sealed at the floor-to-wall junction and may allow moisture penetration and damage.

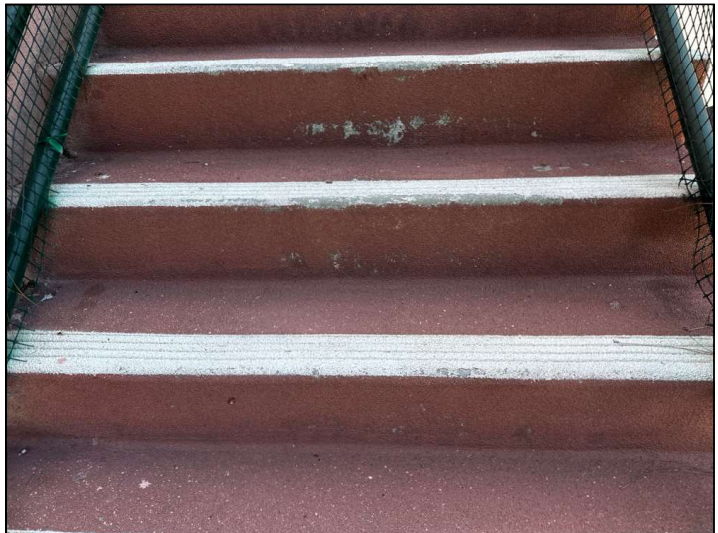
The Magnesite floor coating is damaged, cracked, bubbling or deteriorated. Repairs or resurfacing should be considered.

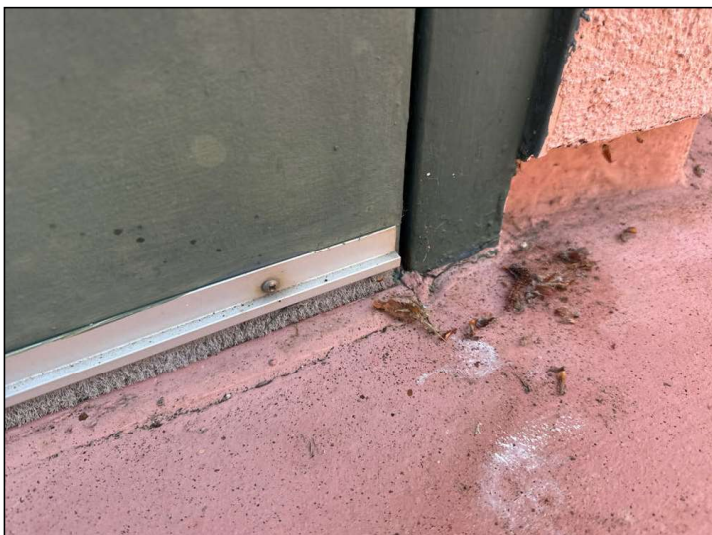
The Door frame/threshold is not properly sealed at the floor junction and may allow moisture penetration and damage.

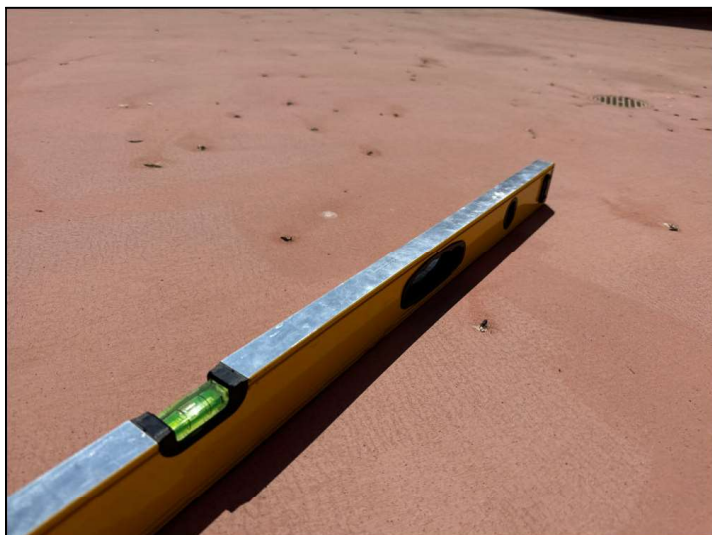
The Balcony floor is improperly sloped towards the structure instead of away. This will cause moisture to pool at the wall-to-floor junction or cause moisture to penetrate into the dwelling.

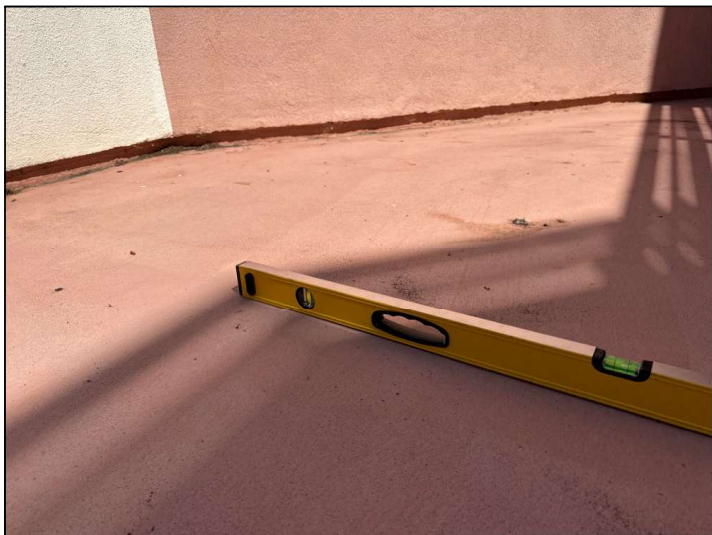
The Balcony floor is improperly sloped towards the structure instead of away. This will cause moisture to pool at the wall-to-floor junction or cause moisture to penetrate into the dwelling.

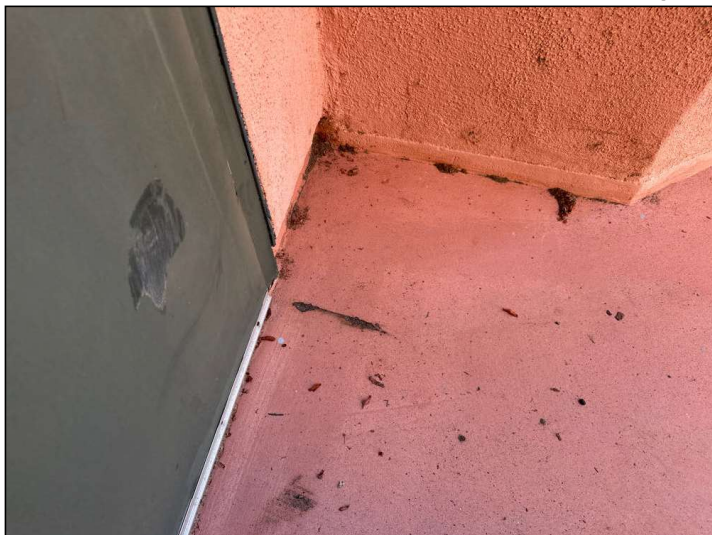
Improper floor drainage or evidence of pooling water was observed.

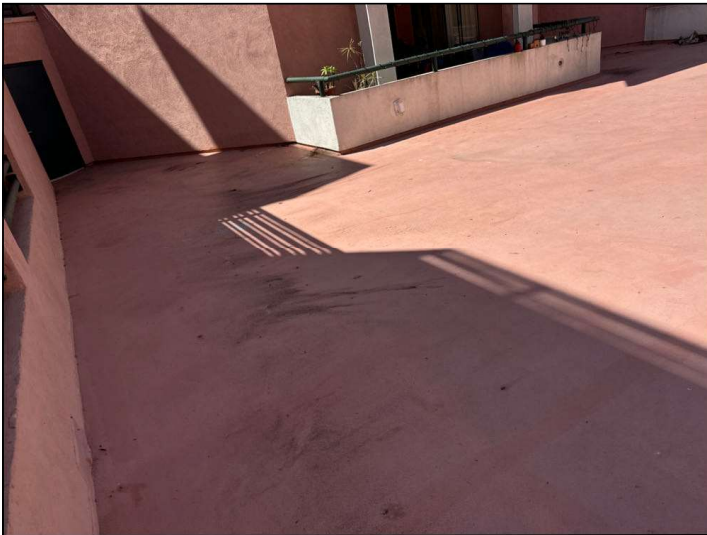
Improper floor drainage or evidence of pooling water was observed.

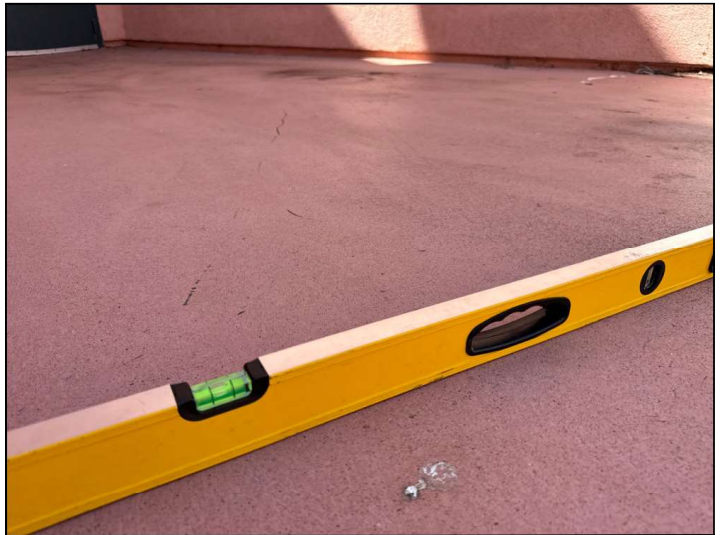
The Balcony floor is improperly sloped towards the structure instead of away. This will cause moisture to pool at the wall-to-floor junction or cause moisture to penetrate into the dwelling.

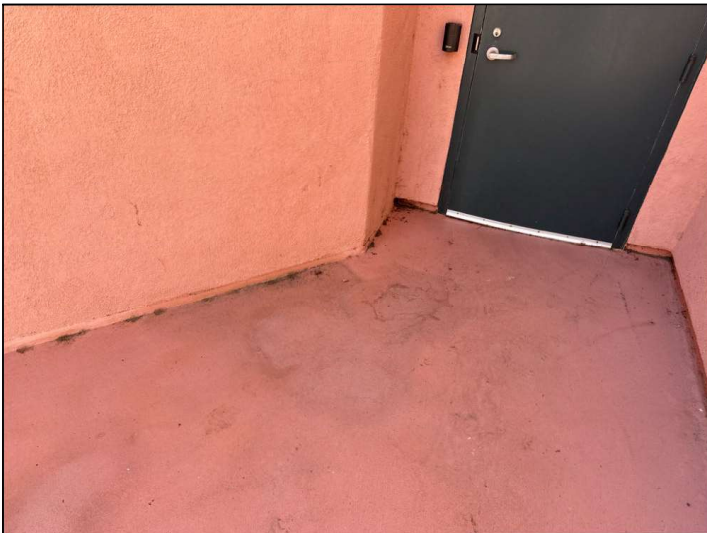
Improper floor drainage or evidence of pooling water was observed.

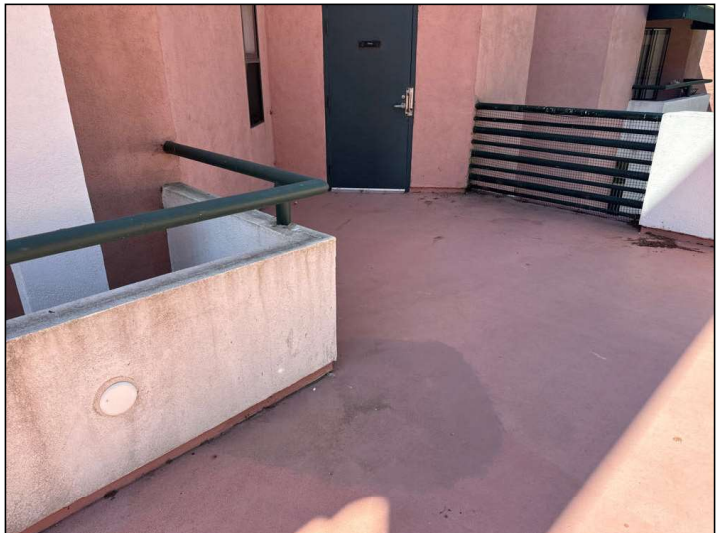
Improper floor drainage or evidence of pooling water was observed.

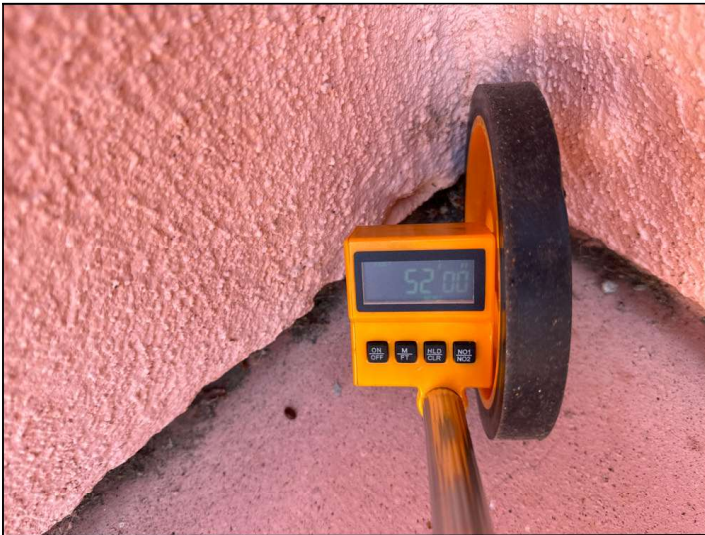
Measurement of balcony in one direction.

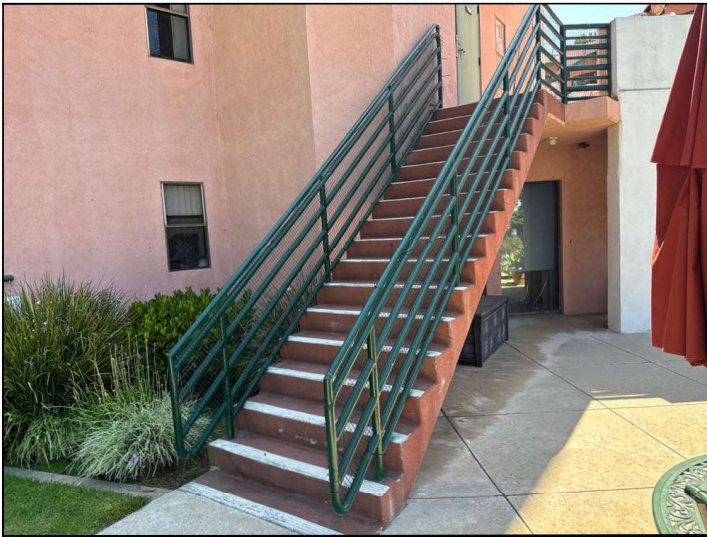
No visible problems were observed with the railings during the inspection.

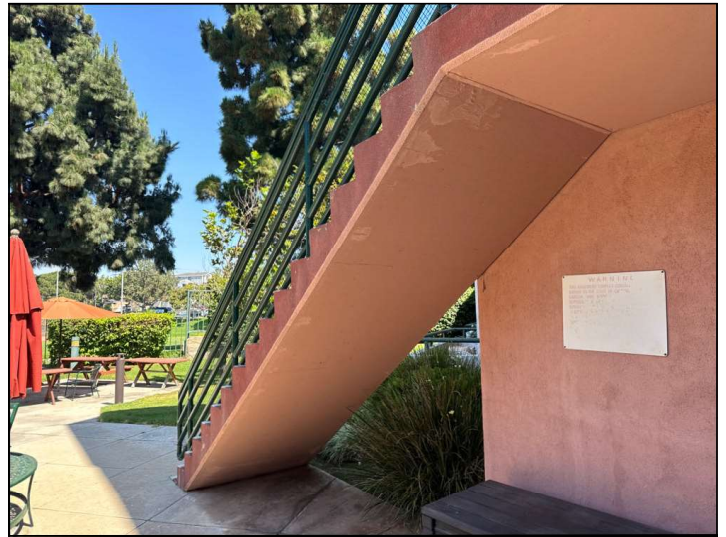
Moisture stains or damage noted under the stairwell.
