CITY OF  
**EL SEGUNDO**

# REPAIR OF DISTRESSED WALLS AND SURFACES AT RECREATION PARK

**PW 25-05**

# General Overview

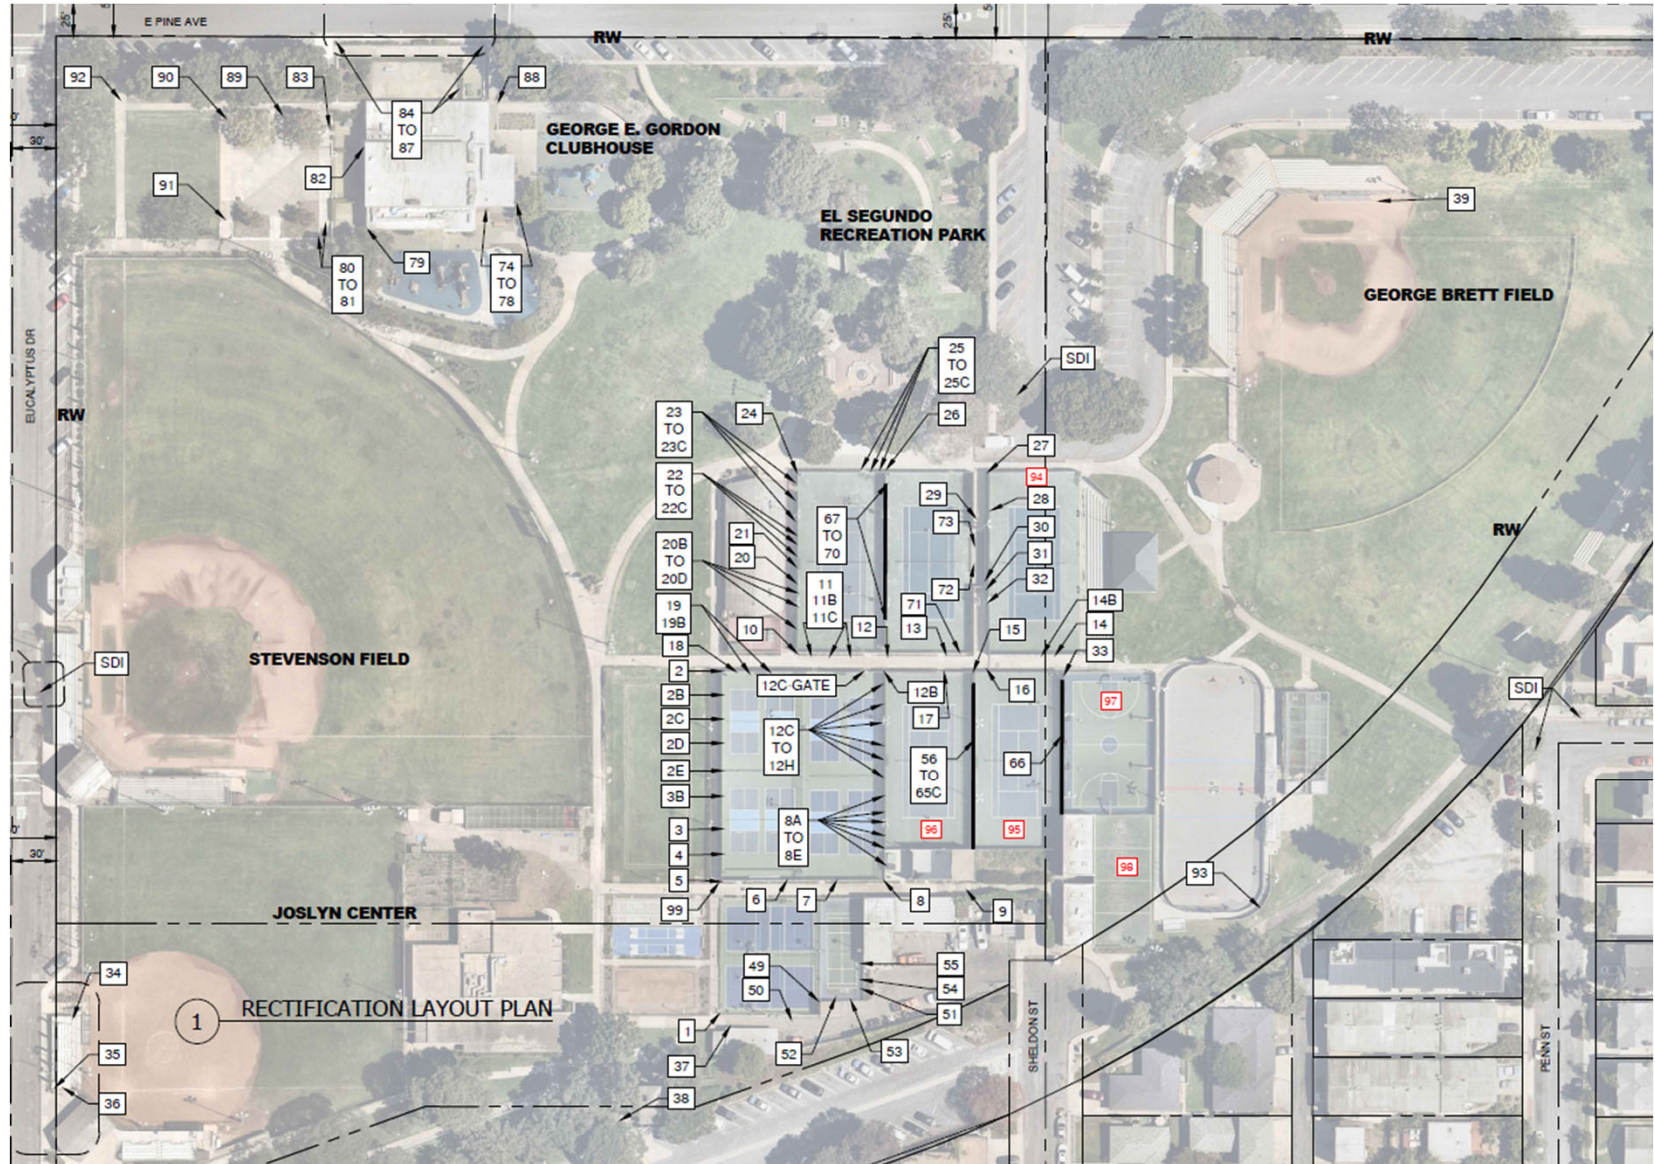
# Location of Distress

1. 93+ repair locations across tennis, pickleball, paddleball, basketball, volleyball courts, bleachers, clubhouse areas, and stairways.
  - i. Work Includes: removal of damaged concrete, rebar repair, concrete replacement, crack and spall repair methods (epoxy, flood coat, injection)
2. 50 Working days
3. Cost Estimate: \$950,000

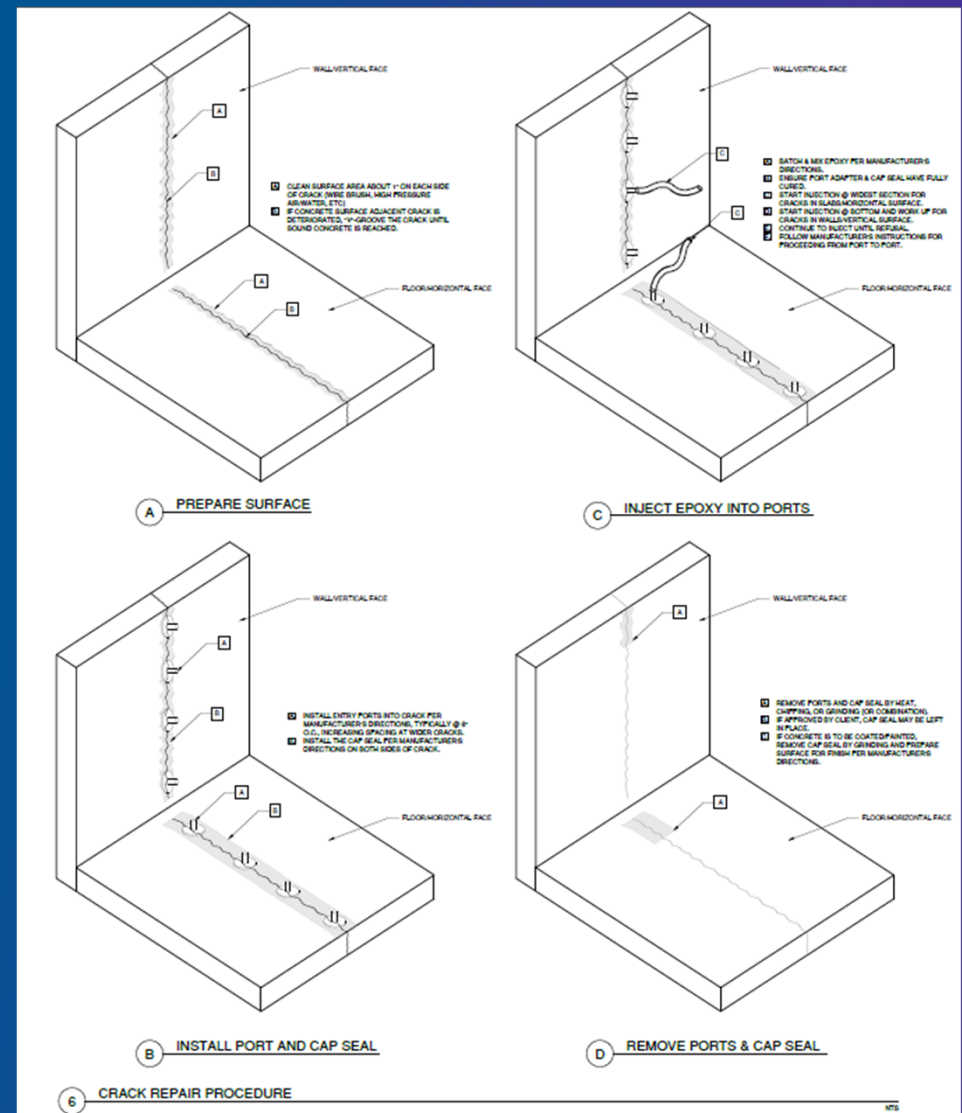
# Court Crack Repair Procedure : Vertical & Horizontal Face

- i. Cracks let in water and weaken the concrete over time
  - i. Small cracks: sealed with liquid epoxy to bond concrete
  - ii. Larger cracks: cleaned and filled with stronger repair material
    - i. Methods:
      - i. Gravity fill (epoxy sinks in naturally)
      - ii. Flood coat (spread to seal many fine cracks)
      - iii. Injection (pump epoxy into deeper cracks)
    - ii. Goal: stop water intrusion, strengthen walls, and extend life of courts
