Urho Saari Swim Stadium

Needs Assessment Report

Prepared for the
City of El Segundo
Parks & Recreation Department

Prepared by
Mithun | Hodgetts + Fung
5837 W Adams Blvd, Culver City,
CA 90232
&
Aquatic Design Group
2226 Faraday Ave, Carlsbad,
CA 92008

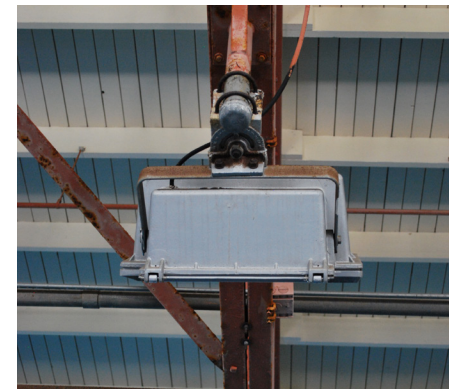
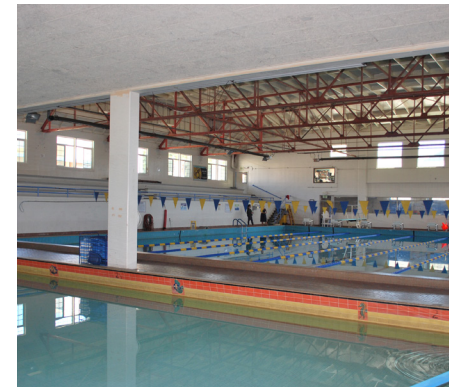
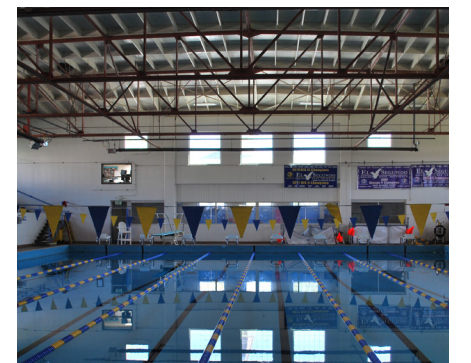
1.1 Observations

1. The pool gutters at both pools have the water more than 12-inches below the top of deck, which is the maximum riser allowed by code.
2. The swimming pool has a shallow end depth of 4-feet, which exceeds the maximum depth of 3'-6" allowed by code. This results in a special purpose pool designation.

3. The swimming pool has wall inlets to return the filtered and chlorinated pool water to the pool. The main drains are not hydraulically balanced as required by code, creating a suction entrapment hazard.

4. The swimming pool lacks a safety line and safety rope anchors in the pool walls to install a safety rope at the 4'-6" water depth as required by code.

5. The door to the mechanical and chemical areas has a placard for the chlorine tablets, but it lacks the placard for the muriatic acid also stored in this space as required by code.

6. The top of the pool is a raised bond beam that is approximately 6-8 inches above the top of deck. L.A. County Health department has ruled that this raised area conflicts with the code requirement of a minimum of 4-feet of unobstructed walk-way around the entire perimeter of a pool.

7. The swimming pool has a portable drop-in stair for better access which conflicts with code requirements to not allow obstructions in a public swimming pool.

8. The facility is using a portable ADA lift for access to the two pools. Such a portable lift does not comply with ADA requirements for equal access to both pools.

9. The water from both pools is co-mingled as a single body of water which is not allowed per code.
10. The depth markers at the waterline lack the "FT" and "IN" notations as required by code. The deck depth markers lack the universal "No-Diving" symbols as required by code.

1. Upgrade perimeter gutters to meet code (See Section 8.0 Programming for options)
2. Adjust water height to meet programming needs by way of altering gutters and pool curb
3. Replace main drain under pool piping
4. Install floor inlets to evenly distribute chlorinated water throughout the pool
5. Install rope anchors and floor markings per code
6. Install code required safety signage throughout pool and mechanical rooms
7. Demolish pool curb and replace with modified gutter system to provide code required access to pools
8. Install permanent access stairs and/or ramps to both pools
9. Install permanent ADA access lift to pools
10. Provide separate water filtration and heating systems for both pools
11. Install code required depth markers and "No Diving" signs per code

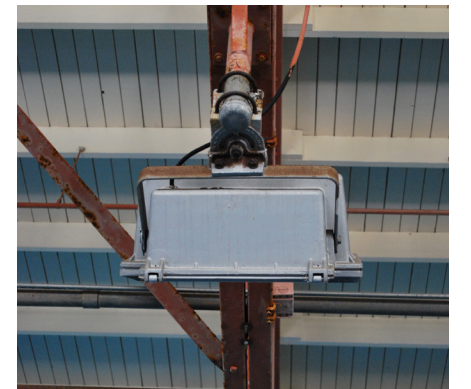
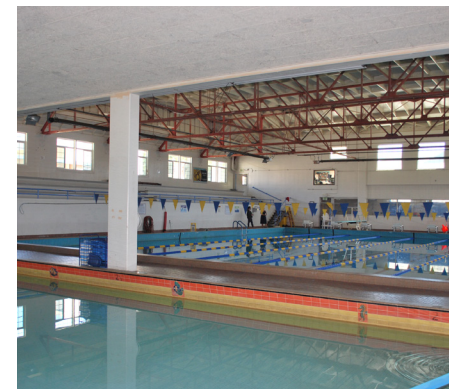
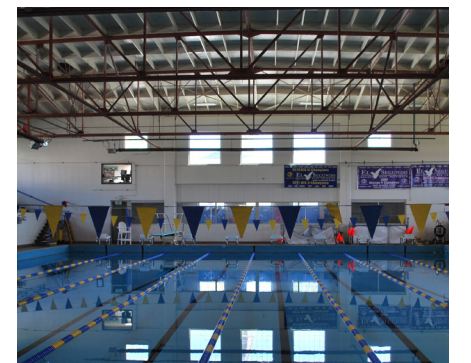
2.1 Observations

1. Windows cause distracting reflections on pool surface creating significant safety issues.
2. Current natural light levels do not provide enough illumination for the facility to operate without supplemental lighting.

3. Halogen light fixtures are outdated and inefficient and frequently need replacement bulbs
4. Rooftop vents do not provide adequate ventilation at the deck level resulting in damp smell and poor air quality within the natatorium

5. Overhead radiant heaters do not provide adequate thermal control throughout natatorium. Users and staff identified heating during the winter months as the primary thermal comfort issue.

6. Acoustic treatments limited to the junior pool ceiling, where the tiles are rotting and do not provide ample acoustic attenuation, resulting in a harsh and reverberant acoustic environment. No sound isolation between mechanical room and pool area. Staff identified acoustics as critical to a safe swimming environment.

7. Staff identified the need for a central PA system for program announcements, music, and events.
8. Staff identified the need for better ventilation and air conditioning in the second-level offices

1. Lighting: Replace LED lighting throughout natatorium
2. New ventilation system with pool level intake
3. New Heating/Air conditioning for Natatorium
4. New split-system heating/cooling for locker rooms
5. Replace rotting acoustic tiles above auxillary pool and add acoustic attenuation in Natatorium
6. Improve ventilation and add mini-split system to staff offices
7. Update plumbing in locker rooms to provide on-demand water heating

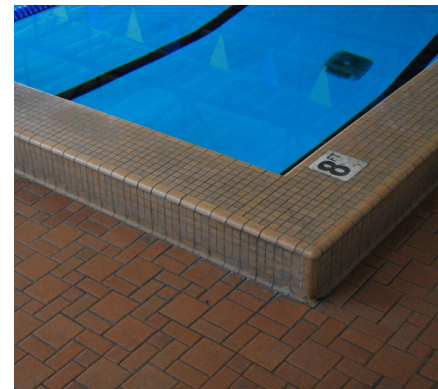
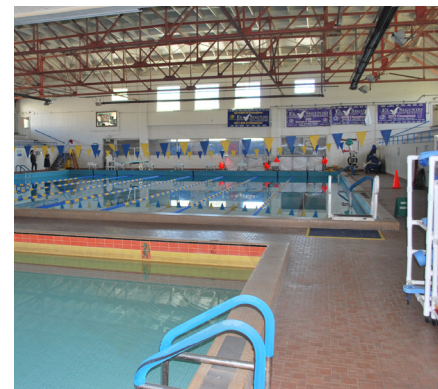
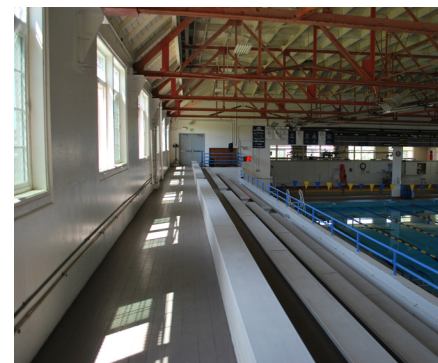
3.1 Observations

1. Access to seating areas from pool deck is limited to a single stair at east stand that is not code compliant
2. Seating rows extend beyond maximum allowable length without an intervening aisle.

3. Seating options are limited to benches designed for large capacity crowds. Users observed that there are no comfortable seating options while observing swim lessons or pausing between workouts.

4. Minimal termite infestation was observed on the grandstand and should be further investigated.
5. Deck level drainage slopes toward pool where a series of floor drains collect water. Code requires that drainage be sloped away from the pool.

6. Non-slip tile surfaces appear to be eroded throughout the pool deck where users observed that the slippery floor is a safety concern.
7. Safe access to both the junior and senior pools is impeded by a raised curb surrounding both bodies of water.

8. No clear sight line from the grandstand to the junior pool.
9. Users commented that there are no seating options surrounding the junior pool for parents observing their children’s swim lessons.

1. Raise pool deck to align with curb to create level access to pool.
2. Create code compliant access from pool deck to both grandstands
3. Provide ADA compliant seating areas at the pool deck level.
4. Provide new seating adjacent to the junior pool.

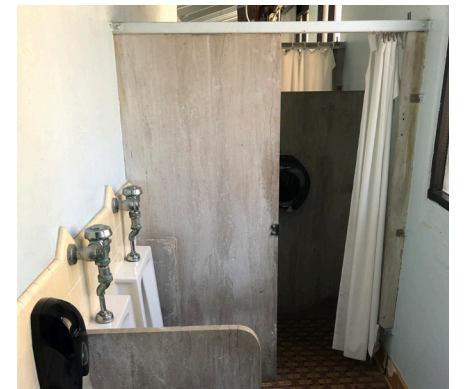
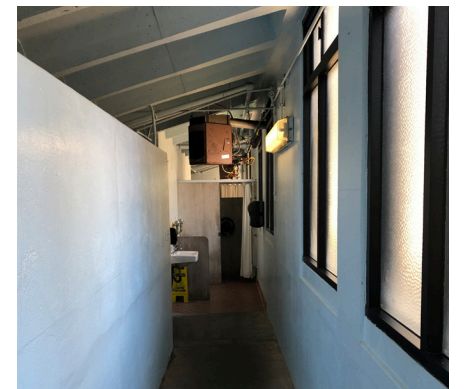
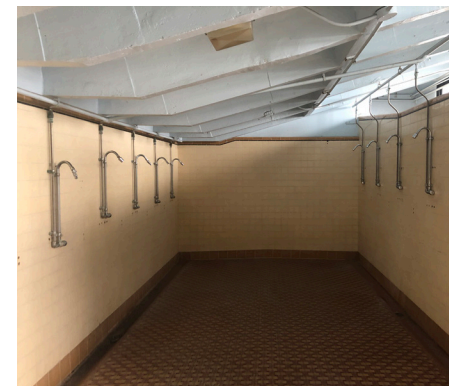
4.1 Observations

1. Restrooms do not meet current code requirements for fixture counts and accessibility requirements.
2. Inefficient use of space in changing stalls and makeup stations
3. Ramps do not meet ADA codes: railing, slope, landing and surfacing
4. Users noted that the showers do not provide consistent hot water
5. No privacy partitions in showers and changing areas
6. No secure and private location for changing and locker storage
7. Lighting is dated and inefficient. Users noted that the locker rooms are poorly lit
8. No separate family restroom facilities are provided
9. Confined access aisles to dressing rooms and showers
10. Staff noted that users of the adjacent playing fields often try to use the restroom facilities in the natatorium. There is no separate access to the restrooms from Richmond field.

1. Provide additional lavatories and toilets in existing locker rooms and upgrade existing fixtures and stalls to be ADA compliant.
2. Add family restrooms at pool deck level
3. Privacy screens for shower facilities
4. Privacy changing stations and lockers
5. Update flooring throughout locker room and access ramps
6. Replace existing lighting with energy efficient LED fixtures

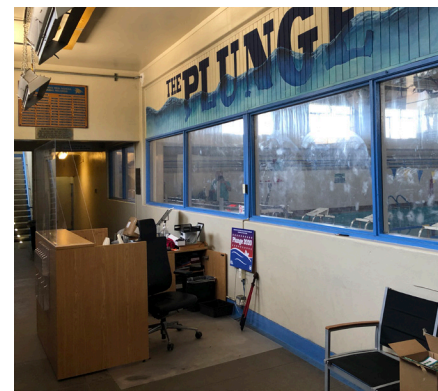
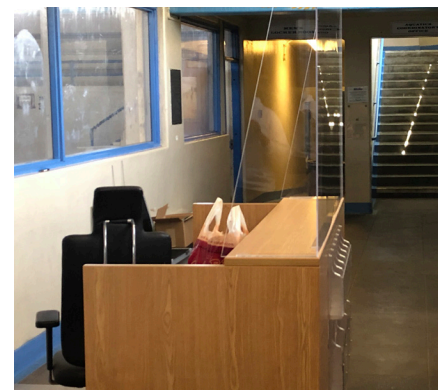
5.1 Observations

1. Radiant gas heaters are inefficient and ineffective at thermal control
2. Location of reception desk creates a bottleneck at the entry area and impedes code-required accessibility to the facility
3. No permanent power and data is provided at the reception desk.
4. Lobby circulation is confusing and wayfinding is inadequate
5. No consolidated control point at check-in desk
6. Users noted that check-in for class reservations and access to the facility is confusing and time-consuming, resulting in overcrowding in the lobby
7. The lobby is decorated with murals, memorabilia, and ephemera related to the history of the building and athletes' accomplishments. Users and staff noted that the history is a significant asset to the building.

1. Expand lobby to increase queue area and create permanent reception desk at new location
2. Create new accessible staff office adjacent to reception area
3. Supply permanent data and power to reception desk.
4. Create single point of access to facility
5. Restore murals and add new display capacity
6. Install wayfinding and other graphic signage

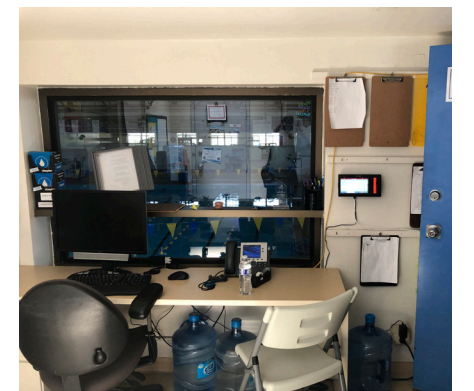
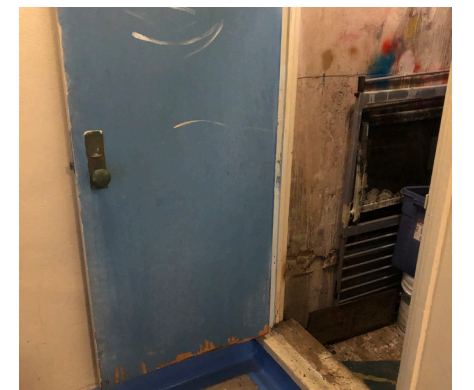
6.2 Observations

1. Storage closets are dispersed throughout the perimeter of the facility with no coherent organization
2. Storage rooms have odor suggesting grime or mold. If they continue to be used, further investigation into the cause of the mold should be conducted
3. Props for swim classes are stored in mechanical room areas, creating impediments on maintenance access space
4. Staff offices are located on the second level and do not provide equal access for employees
5. Staff noted that the guard office is too small, oddly shaped, and does not offer views of the pool deck or quick access in case of an emergency.
6. Loading of chemicals to the facility occurs on a direct route across the pool deck
7. Pool equipment and furniture are stored on the pool deck, restricting circulation.

1. Considerable storage areas in new location adjacent to auxiliary pool
2. Relocate guard office to a position with direct sight lines and access to pool deck

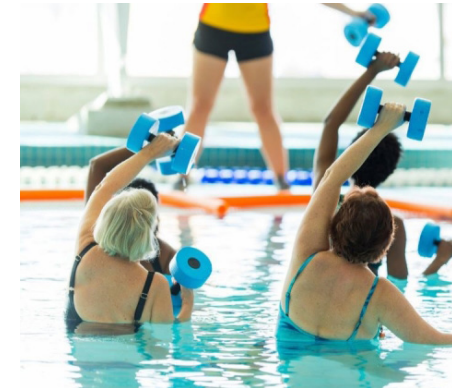
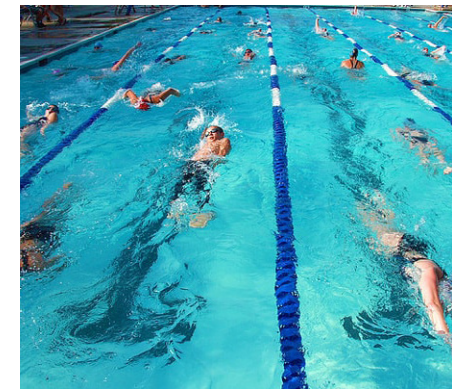
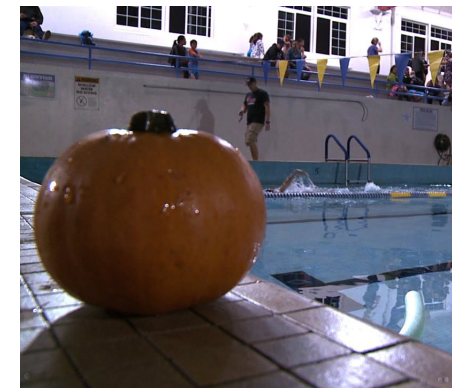
1. The filter tanks are rusting and have been repaired numerous times and should be replaced
2. The existing pump strainer is a cast iron strainer that cannot be readily serviced
3. A review of the staff chemical logs indicates the staff is hand feeding sodium bicarbonate to raise total alkalinity.
4. Pump, filtration, heating and chemical systems are currently manually operated
5. There is no fixed access to the roof for maintenance of rooftop equipment and gutters

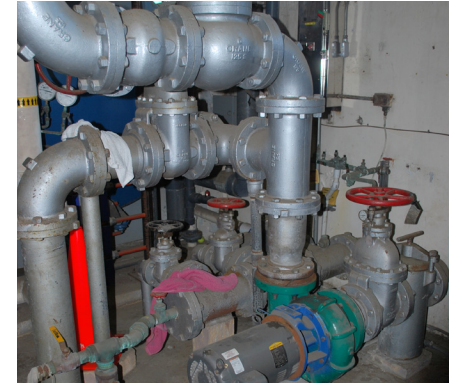
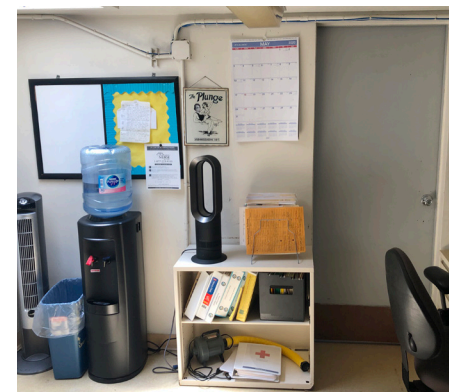
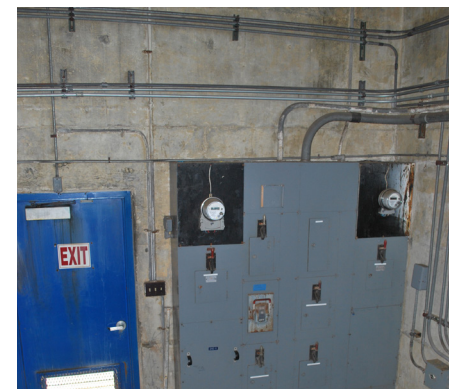
- The grandstands are used frequently. They are heavily occupied during swim meets, water polo games, swim lessons, and special events. Basically, all our programming besides basic lap swimming has patrons in the stands.
- Crowds could most likely be combined into one stand except for water polo games and swim meets. It is nice to have the two separate stands for opposing teams to occupy.
- Parents, teams, organizing in stands. More than adequate. Think about max capacity for single event.

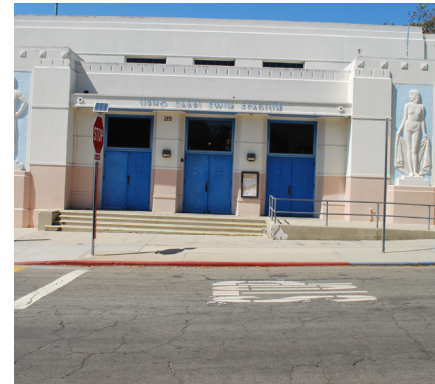
- Acoustics are difficult during several activities. The natural echo of the building causes difficulty hearing coaches and lifeguards as they attempt to yell to swimmers. It is also extremely difficult to make announcements on speakers, or even play music.
- The noise from the boiler room is also quite loud.
- ACOUSTICS – Focus on safety of communication from lifeguards. VERY CRITICAL FROM SAFETY STANDPOINT.
